**INTERNATIONAL SYMPOSIUM ON
DAMS IN A GLOBAL ENVIRONMENTAL CHALLENGES**

**An investigation on the bulging phenomenon in the clay core of rockfill dam
based on the stress and pore water pressure data**

The Masjed Soleyman dam is a central clay core rockfill dam with the height of 177 meter and 490m long center core. Throughout the dam construction, reservoir impounding and operation comprehensive monitoring had been carried out to verify the dam behavior. The monitoring of the dam behavior was based on measurement data of instruments installed on the dam body and foundation. This research present research presents an overall review of the dam behavior during the first impounding and summarizes the recorded measurement of major instruments. These instruments are in the field of stresses and pore water pressure in the clay core. Also substantial rotation of the principal stresses direction had been investigated. The rotating angles of respective points were generally constant, but slight increases in the angles after full impoundment has been observed in the downstream side of the core. This is an indicative of a progressing shear zone and would lead to bulging of the core in the l

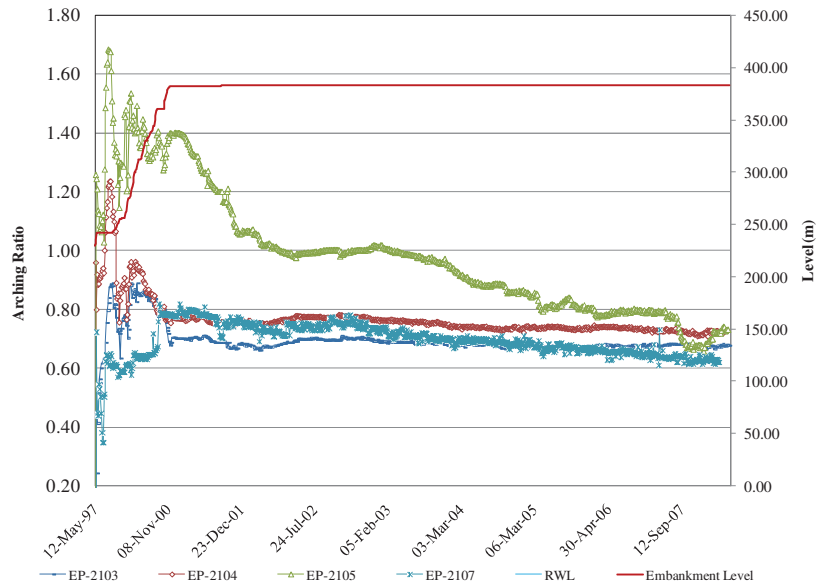
positions of the instrument that was workable are shown in table 2. Variation of the stress ratio (σ_v/γ_H) at respective measuring section (CH. 260) are shown in figures 2 to 4. In these graphs, RWL is the water level behind the dam. The stress ratio in the core was in a range (0.6 -0.7) and that in the filter are (0.7-1.40). This phenomenon caused by arching in the core zone.

Figure 2. Vertical stress ratio at 230 elevation (CH. 260 m).

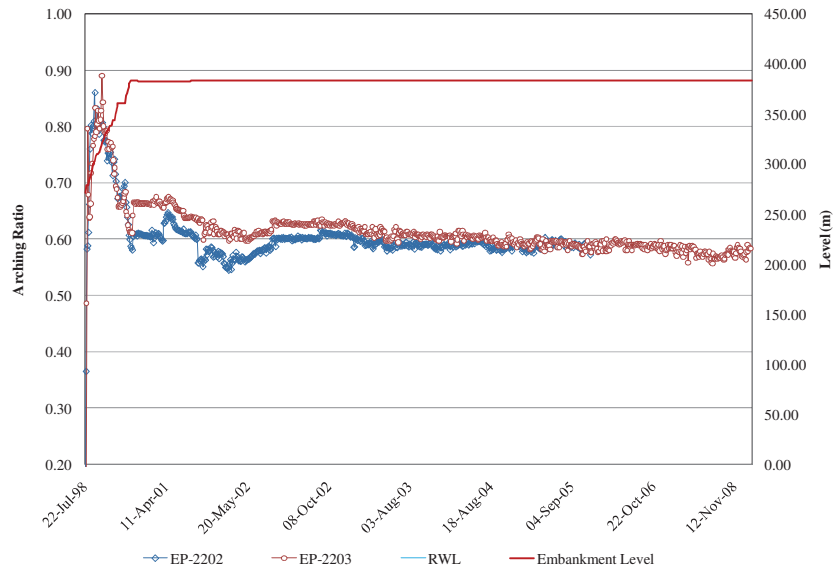
Figure 3.Vertical stress ratio at 270 elevation (CH. 260 m).

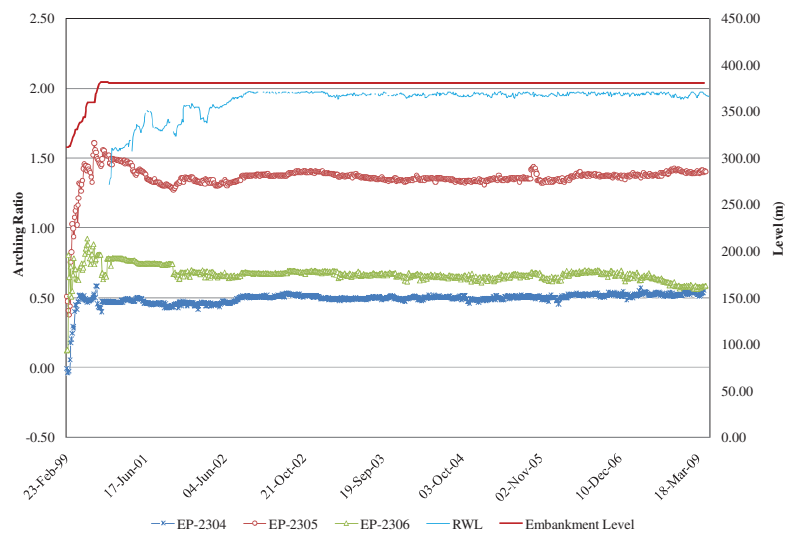
Figure 4.Vertical stress ratio at 310 elevation (CH. 260 m).

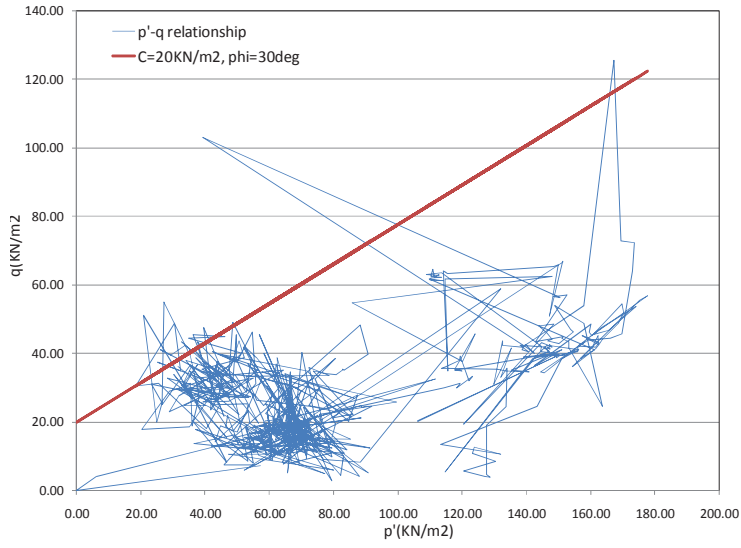
Principle stresses in the dam body are calculated from the measurement data of the total pressure cells at the respective measuring points. Variations of the effective stress paths in the core expressed with relationship between $p = (\sigma_1 + \sigma_2) / 2$ and $q = (\sigma_1 - \sigma_2) / 2$, together with the measured pore pressure (p_u) in this equation $p' = p - p_u$. The values are shown in figure 5 to 7 which indicate a trace of Mohr's stress circle peak. The strength parameters in this failure criterion are soil cohesion and internal friction angle. The values of them are 20 kN/m^2 and 30° respectively. The points above the failure envelope show the yielding condition.

Figure 5. Effective stress path in $(p'-q)$ space (Sec. 260, El. 230, Core CL)

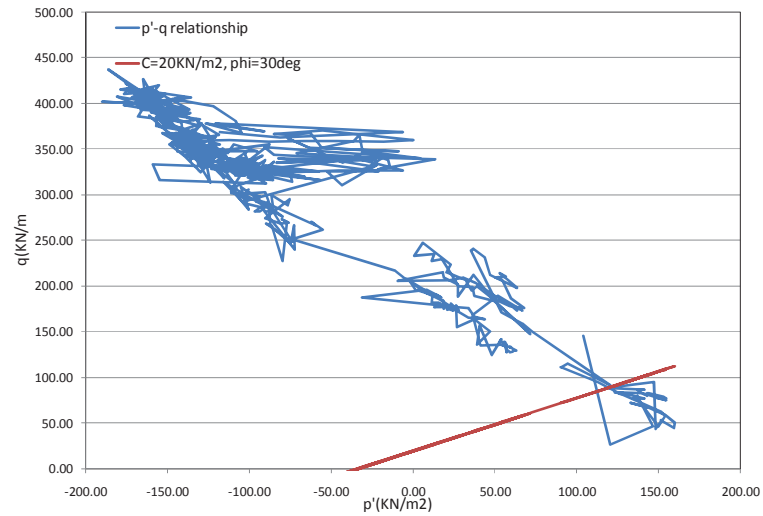
Figure 6. Effective stress path in $(p'-q)$ space (Sec, 260, EL230, Core D/S)

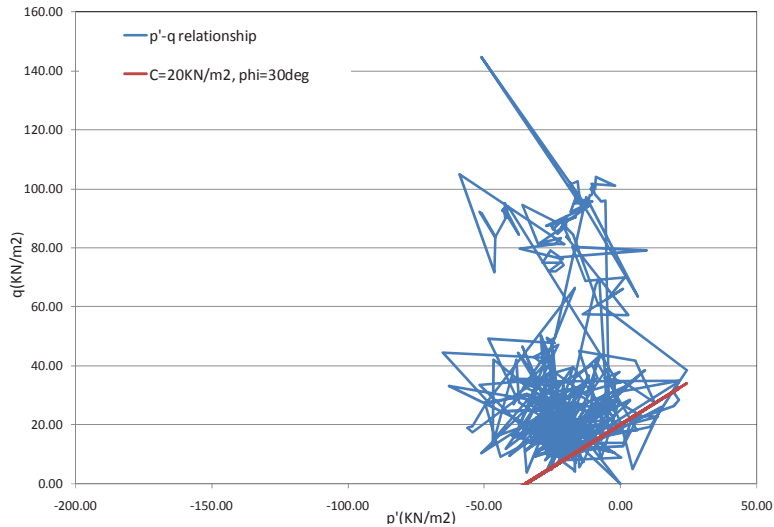
Figure 7. Effective Stress Path in (p' - q) space (Sec. 260, EL270, Core CL)

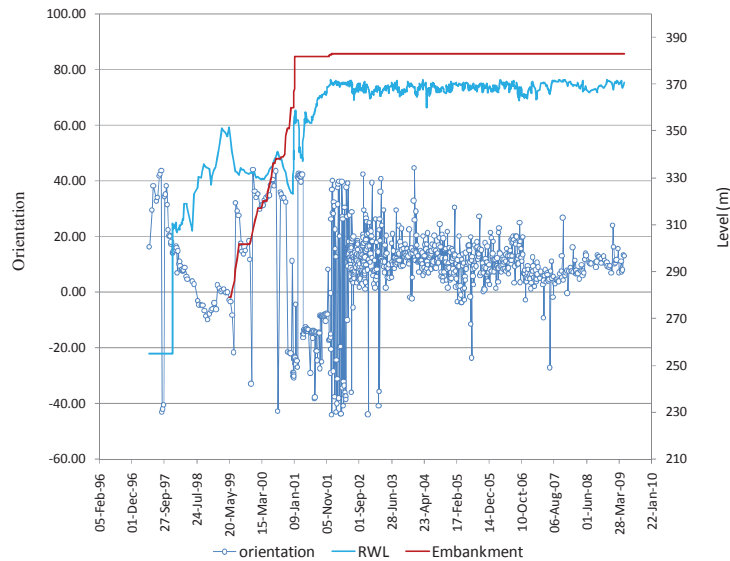
Deviation of the orientation of the maximum stress from the vertical direction is presented in Figures 8 and 9. These graphs pointed out substantial rotation of the principal stress direction to the upstream in the core, which was indicative of a progressing shear zone and would lead to bulging of the core.

Figure 8. Orientation of principal stress direction (Sec, 260, El. 230)

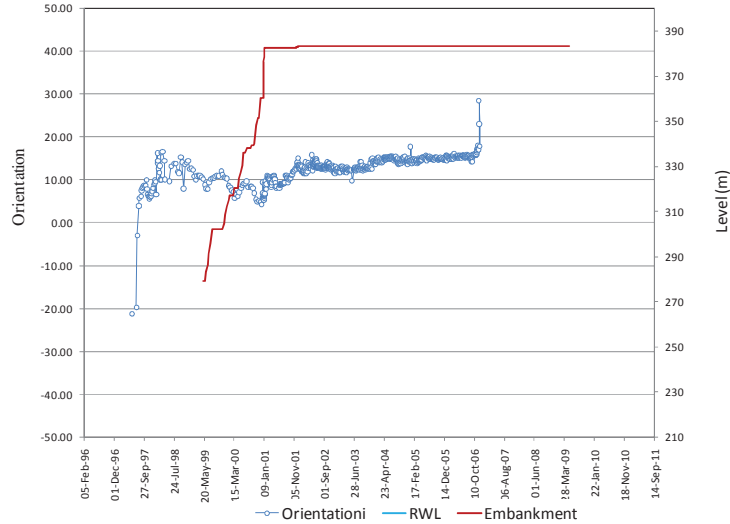
Figure 9. Orientation of principal stress direction (Sec, 260, El. 230)

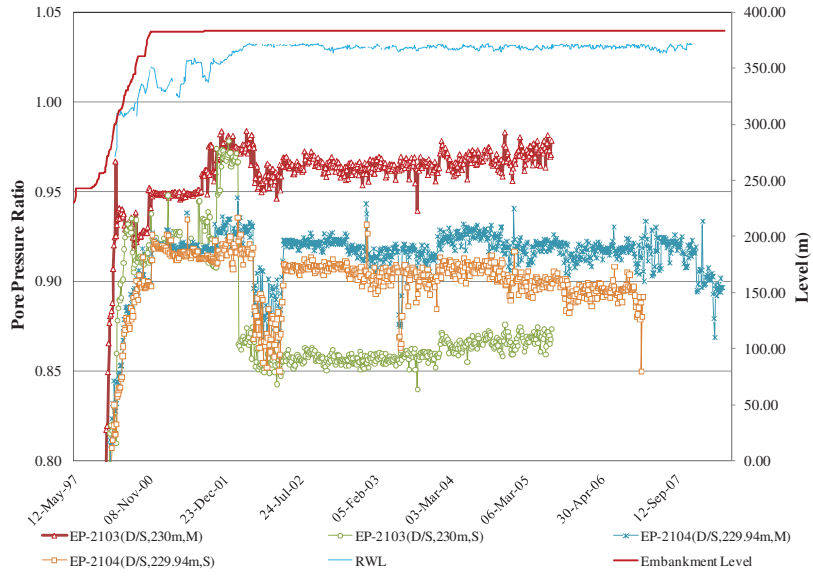
A ratio of the pore pressure to the measured vertical earth pressure (letter M in graphs) and to the principal stress (letter S in the graphs) are shown in figure 10-12. Variation of these values indicates a dissipating process of pore water and air from the core. The level of the pore pressure ratio after 11 years from the embankment completion was high. These had been continuously decreasing since the full impoundment at a slow rate.

The ratio of the pore pressure in the lower portion of the core was still at the high values of 90%. Therefore, the measurement results were simply indicative that the dissipating process of the pore pressure in the core of the MES dam was extremely slow.

Figure 10. Pore Pressure ratio at 230 elevation (CH 260)

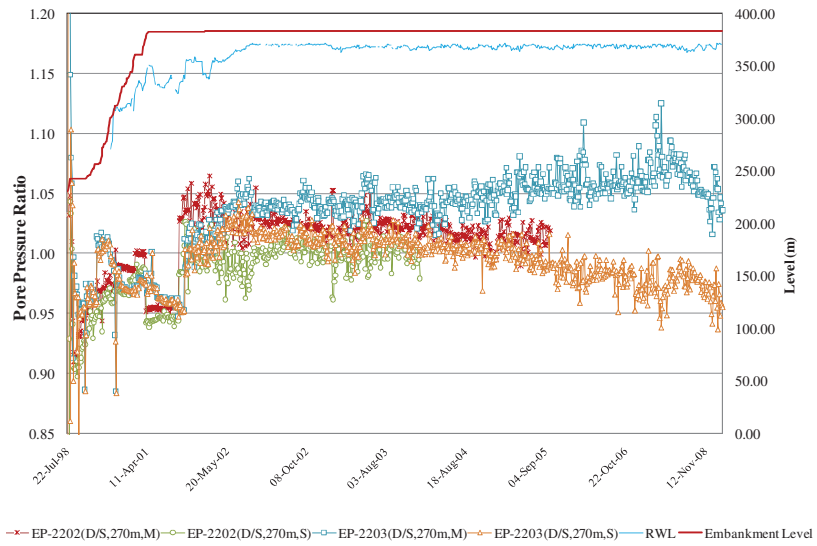
Figure 11. Pore Pressure ratio at 270 elevation (CH 260)

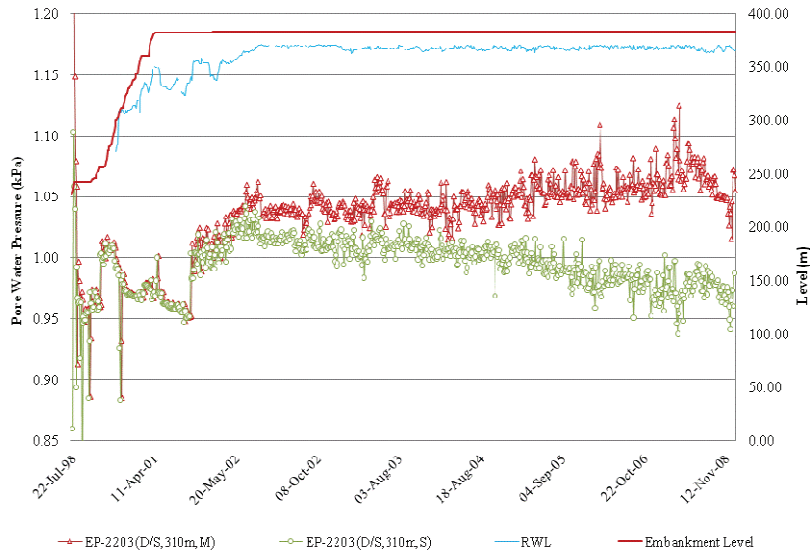
Figure 12. Pore Pressure ratio at 310 elevation (CH 260)

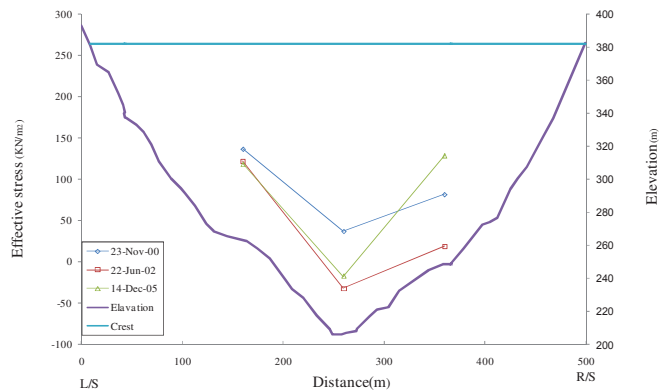
Variation of the effective stress in the middle and downstream part of the core at 280 elevation are shown in figures 13-15. In these graphs, horizontal axis is the distance of the left side to right side of the dam axis and the elevations of abtuments are shown. Effective stress in the CH. 260 had been very little increased after impounding, this mater indicates that the condition is undrained and the progressive of consolidation is very low. Also at 310 elevation in CH260 the effective stress have little increase after impounding (report on monitoring of MS dam behavior, 2014).

Figure 13. Effective stress in middle part of the core at 280 elevation along the axis' dam

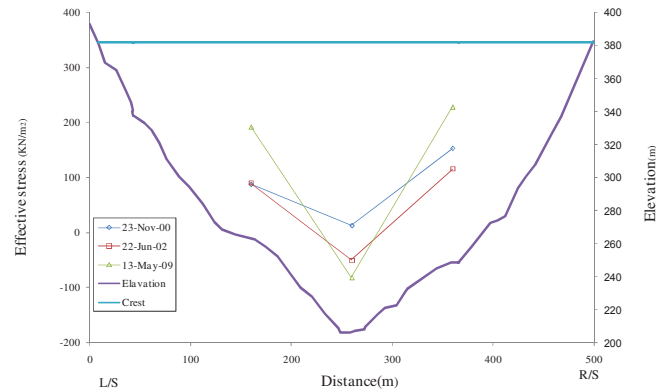
Figure 14. Effective stress in downstream part of the core at 280 elevation along the axis' dam

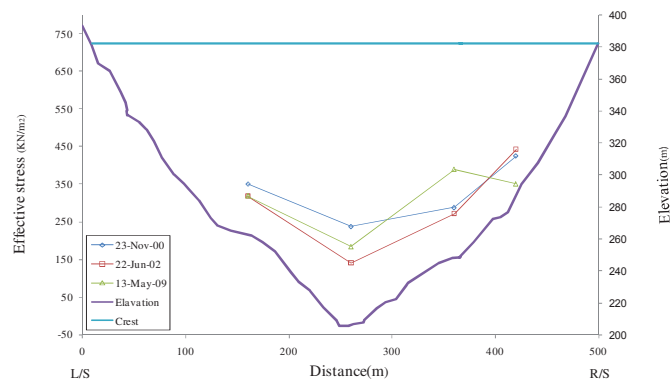
Figure 15. Effective stress in downside of the core at 310 elevation along the axis' dam
