Evaluation of Grout Curtain Performance and Seepage Behavior in Doosti Dam, Iran

Hamid Saeidi¹, Mohammad Ghafoori^{2*} and Gholamreza Lashkaripour²

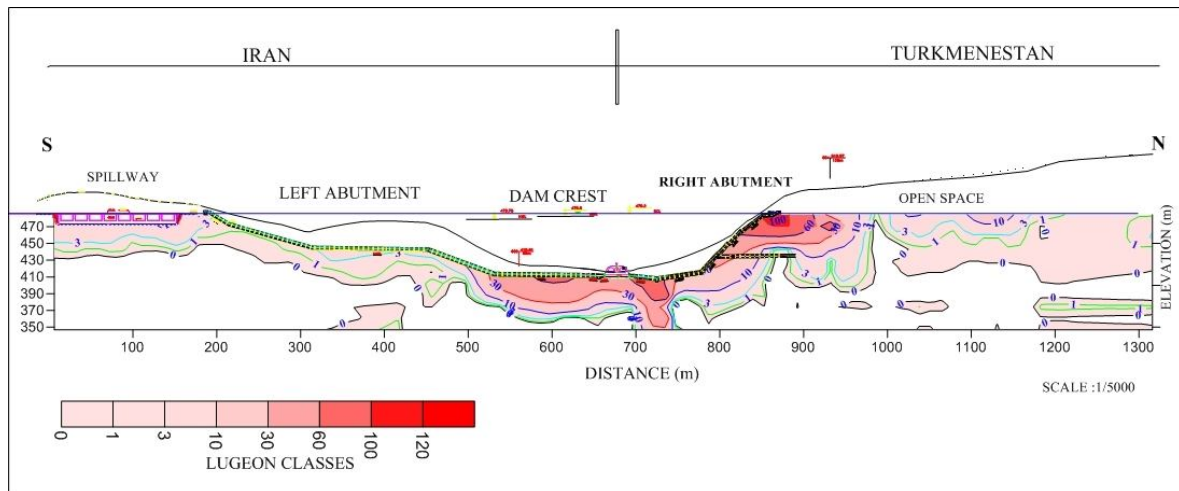
Figure 4. Lugeon value iso-lines along axis of doosti dam

As depicted in figure 4, the left abutment is impermeable and in maximum have very low permeability from near surface to the depth of 5 meters ($LU < 3$). The rock foundation from the spillway area to the depth of 10 meters have low permeability ($LU = 3$ to 10) and is impermeable in higher depths.

The foundation rock in the middle part of the dam or the river bed in the Iran section, have high to medium permeability ($LU = 10$ to 60) to the depth of 25 meters below the grouting gallery. By increasing depth, permeability is decreased and below 35 meters of depth, the foundation rock becomes impermeable. In the Turkmenistan section, to

the depth of almost 40 meters, it has medium (LU=10 to 30) to very high (LU>60) permeability and below that depth, it starts decreasing such that below 50 meters, permeability is decreased to values lower than 3 Lugeon.

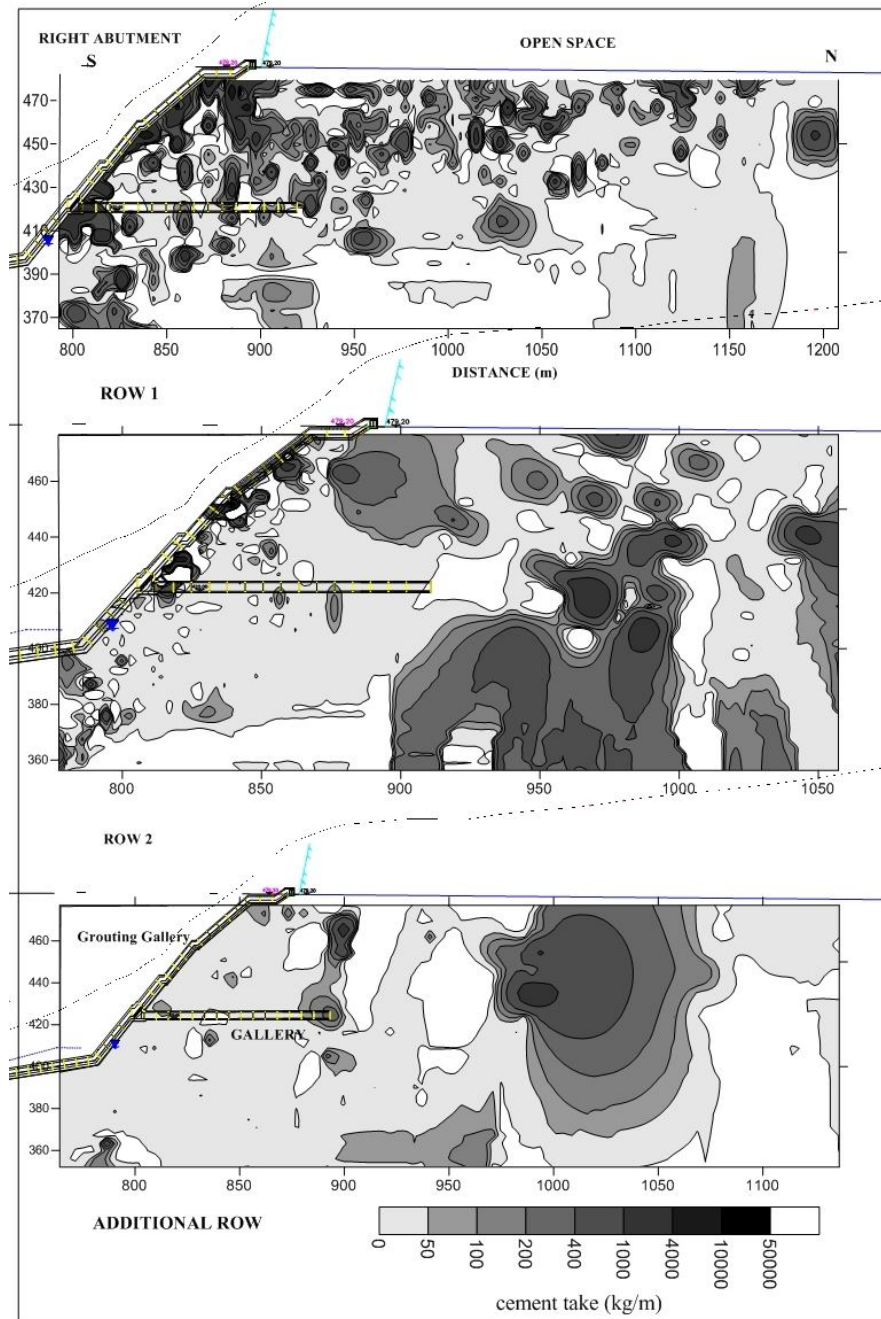
Figure 6. Iso-cement take curves of the right abutment of doosti dam in the first, second and additional rows.

As shown in figure 6, assessment of iso-cement take curves in the first row of grout curtain in the right side indicate that there are numerous areas with medium to high cement take. These areas are located in the right abutment in grouting gallery to the depth of 15 meters and in the open space to the depth of 40 m. A linear zone with 100 meters of depth is observed at the end of grouting gallery in the right abutment with very high cement take which have high cement take in the next two rows as well.

Cement take in the second row boreholes in the right abutment and open space are decreased significantly (less than 50 kg/m). However, there are still points with medium to high cement take that are mostly located in the open space.

In the additional row boreholes, cement take in most of the points in the right abutment and open space are decreased to very low values (less than 12.5 kg/m). Linear zone at the end of grouting gallery and another zone in open space still have medium to high cement take. These zones are weak points and have the potential to transfer reservoir water to the downstream. Finally, the amount of rock cement take in the right side is decreased by implementing continuous rows of grout curtains.

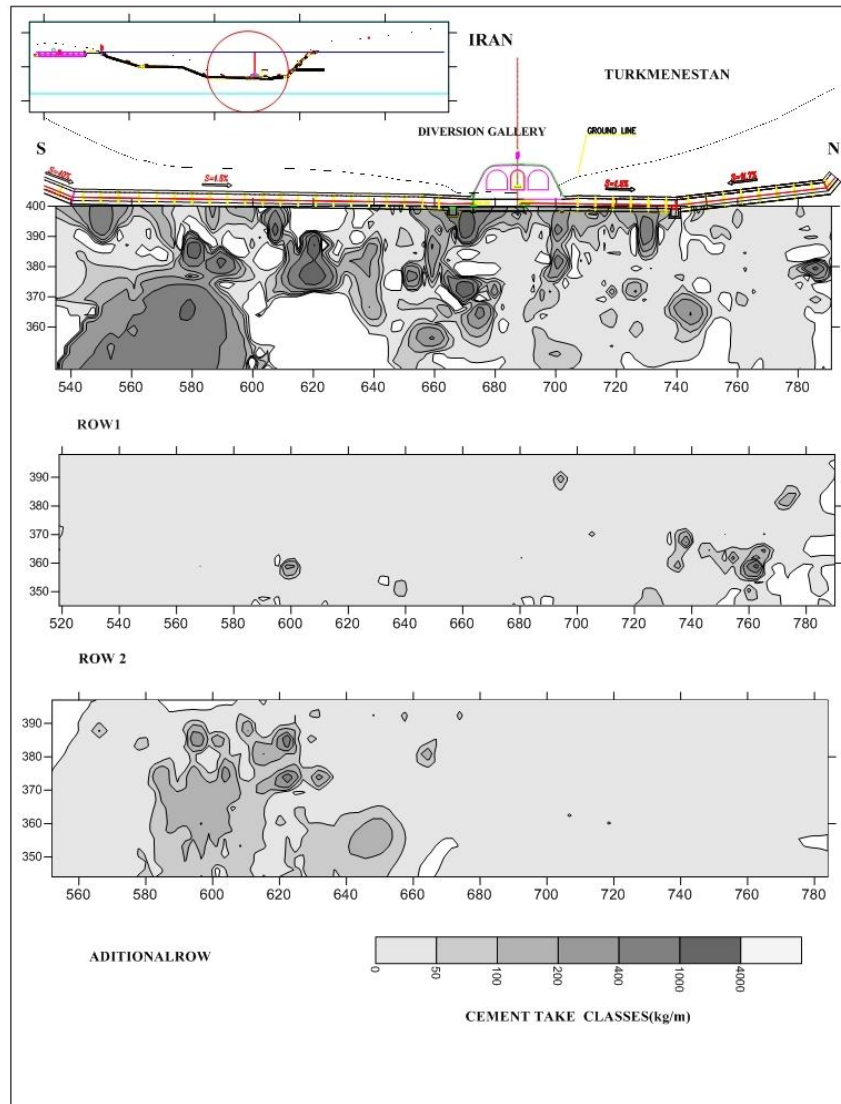
Figure 7. Iso-cement take curves of the grouting curtain in the middle part of the dam

In the first row boreholes of the grouting curtain (vertical boreholes), most of the cement take were in surficial parts below the grouting gallery to 10 m depth. Cement take is Iran section of the dam is more than the Turkmenistan section.

Cement take was substantially decreased in the second row boreholes. In both sides of water diversion gallery, besides from a few sections, the cement take was below 50 kg/m. This decrease in cement loss shows the success of the first row of grouting.

In the additional row, cement take in the rock units on the right side of water diversion gallery reached to less than 50 kg/m. However, in the left side, with the increase in the boreholes angles, there were points with medium to high cement take. Appearance of these points was due to the high angle of boreholes compared to the Turkmenistan section.

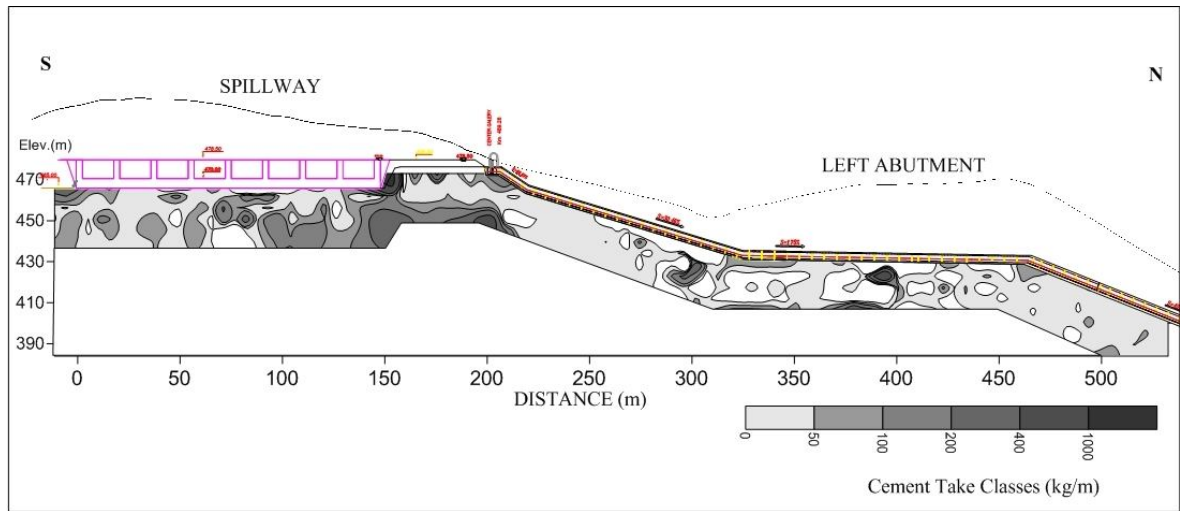
Figure 8. Grout curtain iso-cement take curves in the left abutment and spillway

As depicted in this figure, cement take in the left abutment in most of the points is below 50 kg/m. In the spillway part, there is more cement take which is mainly due to the surficial weathered joints, but in the depth the rock is impermeable.

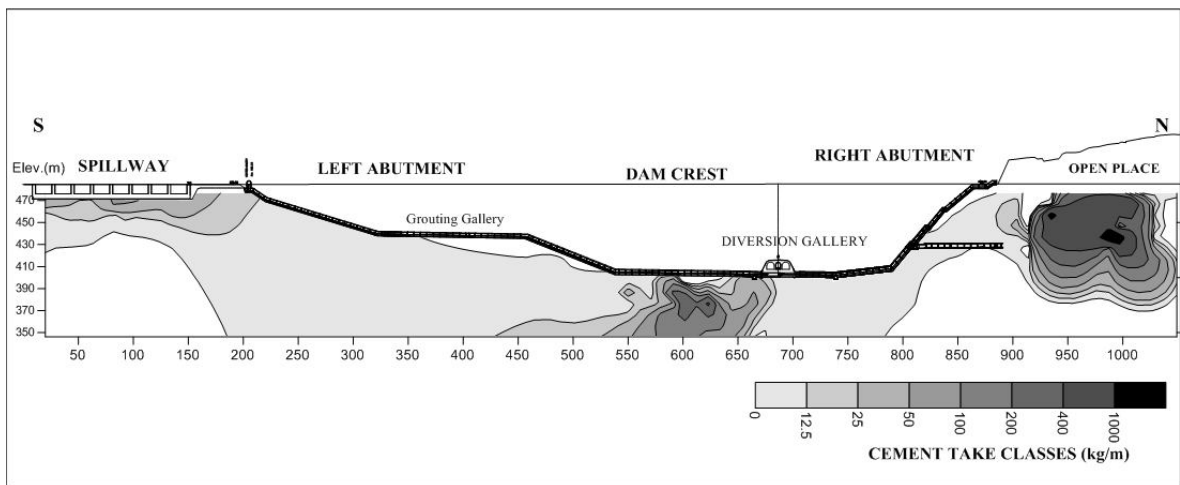
Figure 9. Iso-cement take curves in control boreholes

As depicted in figure 9, in most parts of the grout curtain, the cement take is reduced to less than 50 kg/m. The only place with high permeability and high cement take was some part of the foundation in the Iran section and the open space in the right side where there was contact with the lake. This has caused water escape and other problems in the operation of the dam.

In the right abutment and open space grout curtain, there is no coordination between Lugeon results and cement loss. Points with medium to high cement take in the foundation and open space control logs show that there are still zones with permeabilities higher than 3 LU after the implementation of the grout curtain. These points are pathways for water escape and pose risk on dam's stability during operation which mandates a re-grouting program.
