# A new equation proposed for evaluation of IR drop on buried pipelines

**Purpose** – In this investigation, attempts were made to distinguish critical coating faults in order of repair priority in DCVG + CIPS survey data by new proposed equation for calculating IR drop. The paper aims to discuss these issues.

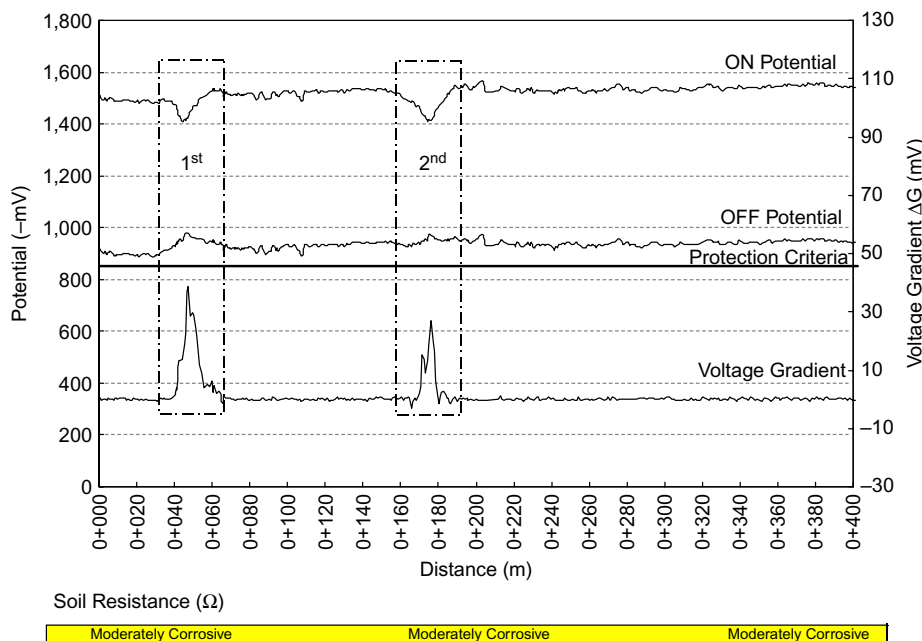
**Figure 2** DCVG + CIPS data of AL65 pipeline

diagrams of the AL65 pipeline (Figure 2) showed two distinctive HVG regions (HVG regions are the regions where the difference in voltage gradient ( $\Delta G = G_{\text{ON}} - G_{\text{OFF}}$ ) gradually increases from a low value to a maximum value followed then by a decrease to a lower value again). In consequence, a peak is detectable in the voltage gradient diagram. These results include chainage (measured distance in meters from the start point) 0 + 039.6 to 0 + 064.7 m (Figure 3) and 0 + 169.5 to 0 + 184.3 m with total lengths of 25 m and 15 m, respectively. Direct inspection followed by excavation of these regions proved that the main coating faults were disbonded coatings with severe corrosion and voluminous oxides all around the pipelines under the disbondedments (Figure 3). In order to reach bonded coatings to pipe metal, the first HVG region was extended to 62 m. Three pipes with a length of 12 m (36 m) were replaced, due to extent of corrosion, and the entire length of 65 m was recoated. The second HVG region was extended to 37 m and one pipe (12 m) was changed. The whole repair length was recoated. Figure 4 shows the DCVG + CIPS diagrams of AL99A that had a unique HVG region from chainage 0 + 054.6 to 0 + 065.4 m. Similarly, direct inspection after excavation confirmed that the main coating faults were disbonded coatings and voluminous oxides were observed around the pipes (Figure 5). In a same manner, the HVG region was extended to 53 m to reach satisfactorily bonded coating. 17.4 m of the pipes were replaced and the whole repair length was recoated.

**Note:** First and second HVG region is highlighted, respectively

The calculated percentage IR result based on equation (1) is shown in Table II. The maximum percentage of IR values fall into the first category (1-15 percent), which indicates that the coating faults were of low importance. However, as mentioned previously, direct inspection after excavation revealed disbonded coating with severe and voluminous corrosion products required immediate and extreme repair action and the need for pipeline replacement. Due to lack of reliable prediction of the repair priority, IR percentage drop values were calculated using equation (2).

Table III shows the recorded potentials in the second HVG region. As can be noticed, the maximum IR drop value calculated from equation (1) was 6.1 in this region, requiring no action for repairing. However, line excavation followed by direct inspection showed that severe corrosion had occurred under disbonded coating areas, emphasizing not only that coating repair was required but also pipeline replacement was necessary.

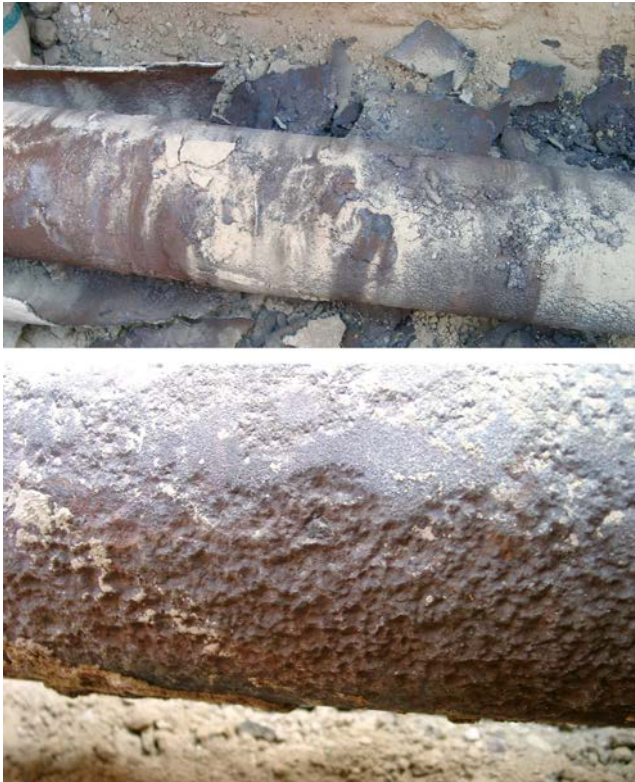
Figure 3 First HVG region of AL65 pipeline and the shape of corrosion

It is now clear that the calculated value should belong in the fourth category of %IR, which emphasizes the necessity of repairing the pipeline at the earliest convenience.

Figures 3 and 5 clearly show the form of corrosion attack on the pipeline. At first glance, pitting might be considered to be the form of corrosion. In order to have a clear understanding of this issue, XRD and EDS analyses were undertaken on the corrosion products (Figures 6 and 7). The results showed that the predominant oxides were hematite ( $\alpha\text{-Fe}_2\text{O}_3$ , dark red or

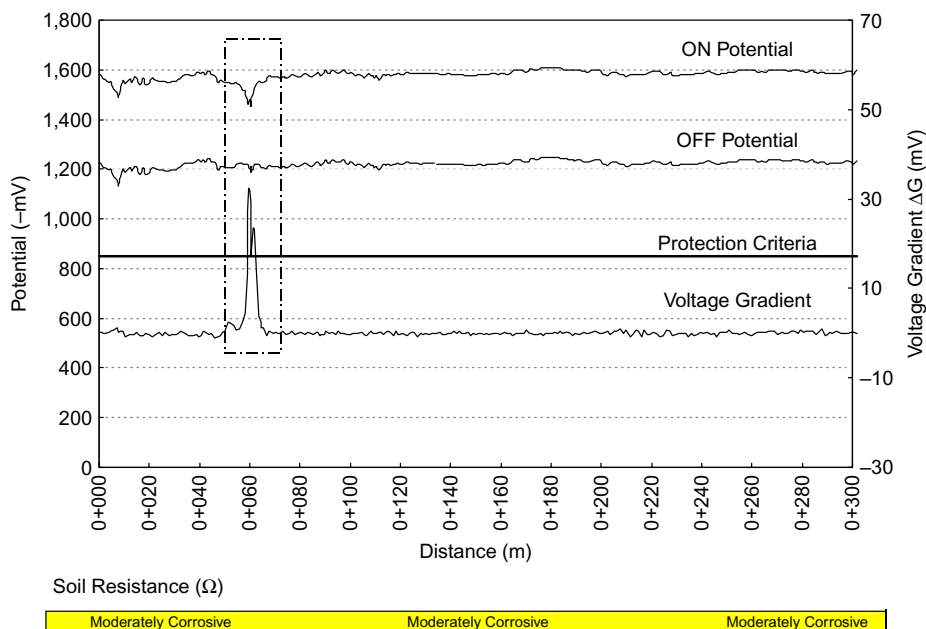
Figure 4 DCVG + CIPS data of AL99A pipeline

Table IV shows the recorded potential of AL99A at a high potential region. In a same trend, and contrary to the findings of direct inspection, the calculated IR result from equation (1) fails to predict the repair priority in the HVG region.

$$IR\% = \frac{31.7}{84} \times 100 = 37.4 \quad (11)$$

Note: HVG region was highlighted

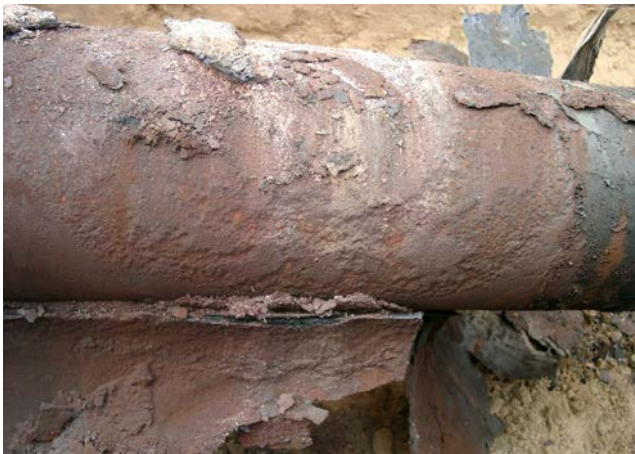
**Figure 5** The HVG region of AL99A pipeline and the shape of corrosion

dark-brown in contact with bare metal) and goethite ( $\alpha\text{-FeO(OH)}$ , light red or red-orange in contact with pipe coating). The EDS results from the corrosion products did not show any sign of Cl anions (Figures 8 and 9), which suggested that corrosion was non-uniform localized general attack (Bagotsky, 2006).
