Archives of Applied Science Research, 2012, 4 (4):1650-1658
(<http://scholarsresearchlibrary.com/archive.html>)

The role of soil engineering in producing bank erosion and morphological changes of Sistan River

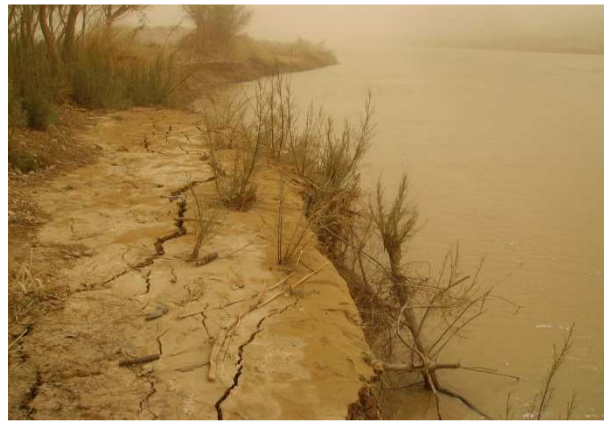
planar failure along with tensile cracks in the materials of Sistan River's bank is the main causes of failure and retreat of the riverbank (Figure 4). In sediments of Sistan River's bank, water can easily erode the sediments after cracks and fissures are created. Figure 5 also shows the piping erosion and the fractured block adjacent to Sistan River.

Fig 4: planar failure along with tensile cracks in the materials of Sistan River's bank

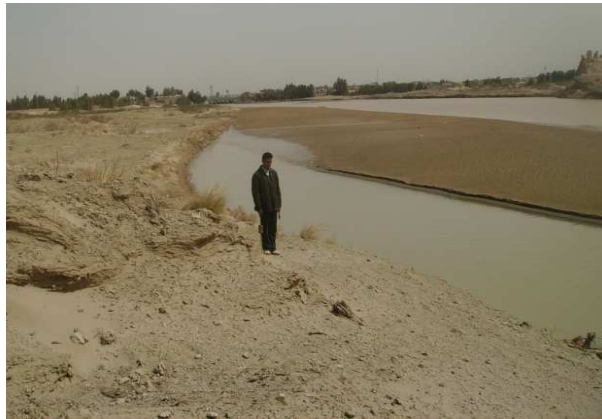
Figure 6. Sediment accumulation in the middle of the river channel

Sediments of the failure of Sistan River's bank, most of which are fine, are transported in a suspended form in the flow of water downstream. These sediments are accumulated in the basin mouth of hydraulic structures, and cause obstruction of valves, damage to irrigation network pumps, and so on. Field and laboratory studies show that morphological changes of Sistan River - more than any other factor - are affected by bank erosion of the wall materials and continuous sedimentation of river. The river wall erosion has created many problems, such as destroying the farmlands, increasing the river width, threatening the villages adjacent to the river and water pumping systems. Thus, a large volume of lands adjacent to Sistan River annually enters the river flow as a result of bank

erosion, and is carried along with the flow downstream. The above sediments are deposited along the path, and reduce the volume of water entering the river, the efficiency of hydraulic structures, the feed of Hamoon Lake, and so on.

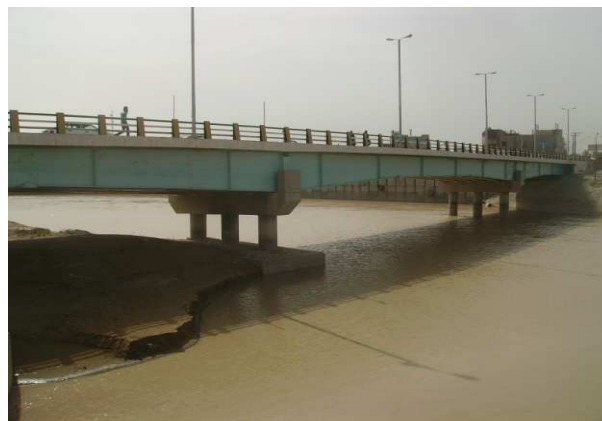
Figure 7. The accumulation of sediment on the site of hydraulic structures
