Behavior of Damaged Exterior RC Beam-Column Joints Strengthened by CFRP Composites

Ebrahim Zamani Beydokhty ^a
Hashem Shariatmadar ^{b*}

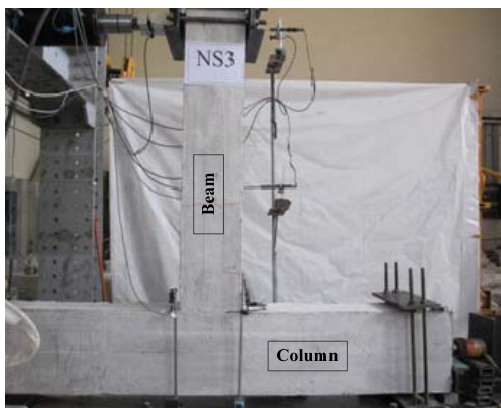
The experimental setup for specimens is shown in Figure 3: Test-set up.. The specimens were rotated 90° vertically, so the column placed on the floor of the laboratory and the beam was projected from the floor. The Figure 3: Test-set up. shows the fastened specimen on the strong floor.

The end of beam and columns were points of contra flexure due to lateral loading of structure. The specimens were pin-supported at the mid height of the column connected to the reaction strong floor. A constant axial load about 70 kN was applied at the ends of column. Horizontal displacements were applied at beam mid span through a pin-ended double-acting 800 kN hydraulic actuator.

Five linear variable displacement transducers (LVDT) were used to measure the displacement at various locations on the specimen as shown in Figure 3-b. One 150-mm LVDT measured the beam tip displacement. Three 40 mm LVDTs were attached on the surface of beam and column at the vicinity of joint, and one 150 mm LVDT was mounted on the beam surface at a distance of 600 mm from column side for measuring the beam rotation and curvature.

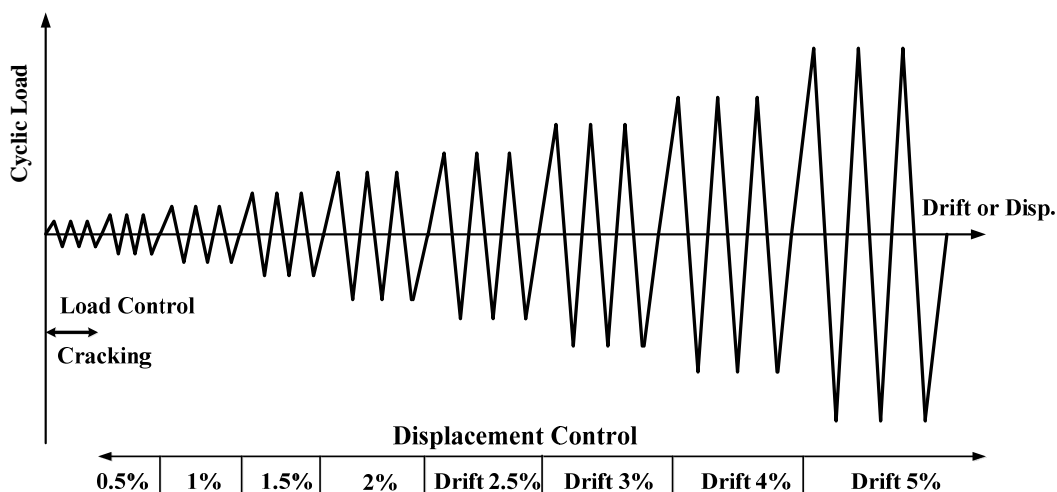
Figure 4: Load history for the reversed cyclic load test.

Cyclic loading was applied to the tip of the beam according to the loading history displayed in Figure 4. Specimens were tested under a load-controlled cyclic in elastic range followed by displacement-controlled cyclic load history based on the inter-storey drift which represented a severe load condition for beam to column joint.

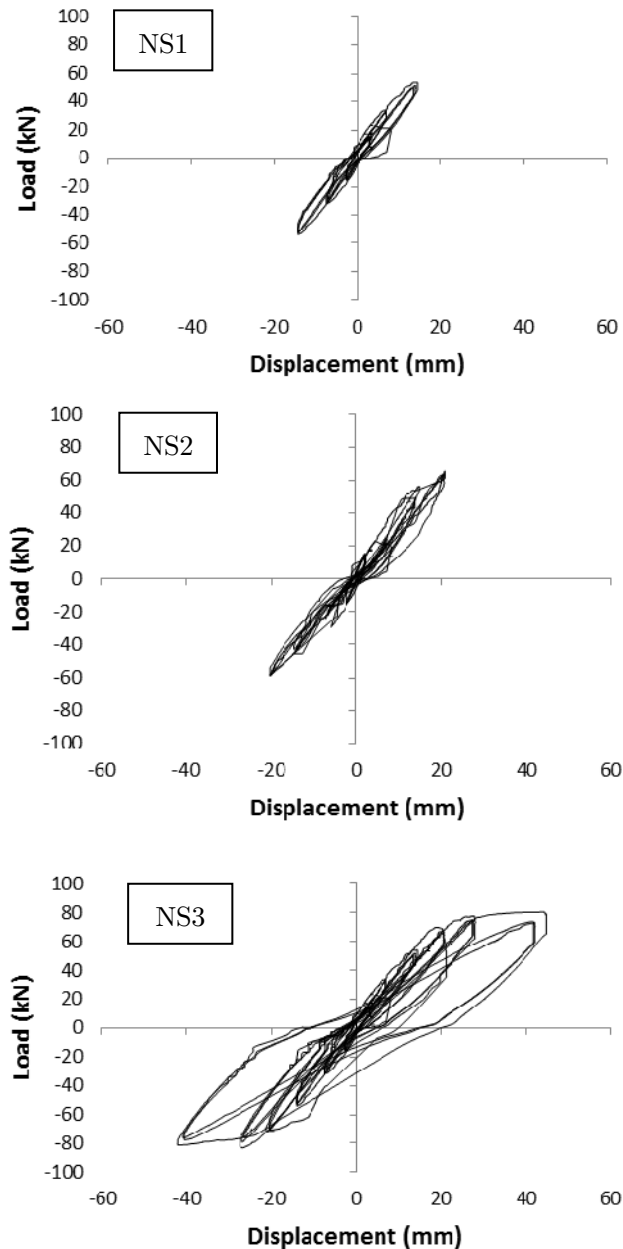
Figure 6: Hysteresis curves of specimens NS1, NS2 and NS3.

According to the NS5 specimen test results as will be presented in the next sections, the drifts 1%, 1.5% and 3% were obtained as the IO, LS and CP performance levels of the specimens based FEMA 273 (1997), respectively. Initial damages were applied on the specimens NS1, NS2 and NS3 up to 1%, 1.5% and 3% storey drift, respectively before the strengthening. The geometrical characteristics and the materials used in the strengthened joints were exactly similar to NS5 specimen. The hysteresis curves of beam tip load-displacement for specimens NS1, NS2 and NS3 are plotted in Figure 6.

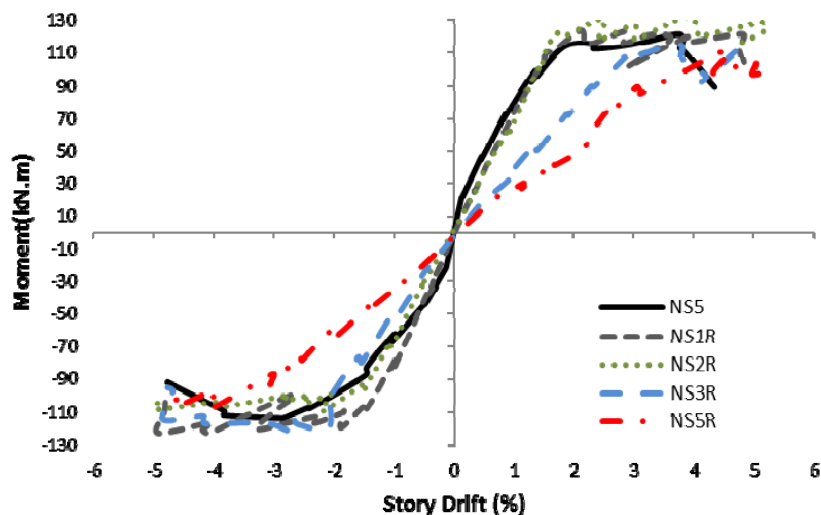
Figure 9: Moment–Storey drift envelopes of reference and strengthened specimens.

Figure 9 briefly compares the specimens' moment-carrying capacities in reversed cyclic loading with that of NS5 specimen.

The summary of load carrying capacity for specimens is presented in Table 1. According to the last column of Table 1, among the specimens that have achieved the capacity of the final drift 5%, only NS5R specimen has a lower load-carrying capacity than the basis NS5 specimen. In addition, the initial stiffness of NS1R and NS2R are very similar to that for specimen NS5.

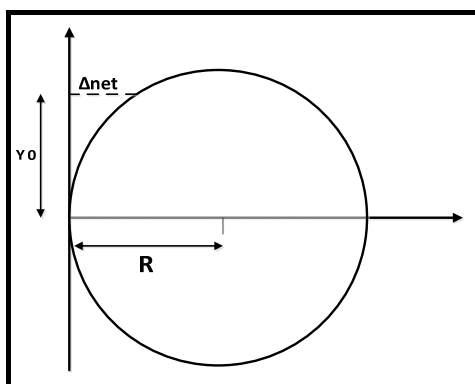
Figure 10: Circular deformation of beam and definition of R.

If the displacement of the LVDT installed at $2h=600$ mm from the joint face is denoted by Δ , it must be noted that the deformation resulted from the rotation of the joint must be subtracted from Δ value. This is done by reducing the rotation of the joint multiplied by $2h$. Assume that the rotation of the joint is θ_j , the beam's net displacement at 600 mm that is denoted by Δ_{net} is obtained from the Equation (1). If it can be assumed that the beam deforms as a circle in its critical zone, the circle radius (R) can be obtained from the circle Equation as Equation (2) and the curvature can be computed from $1/R$ (see Figure 10).

Using Equation (3), the circle radius can be determined from the circle relation and the beam curvature can be obtained by the Equation (4).
