نشریه ماشین های کشاورزی (نشریه علمی-پژوهشی)

"Evaluation of the Plateau Honing on the Friction and Wear Cylinder Liners in Agricultural Tractors"

Evaluation of the Plateau Honing on the Friction and Wear Cylinder Liners in Agricultural Tractors

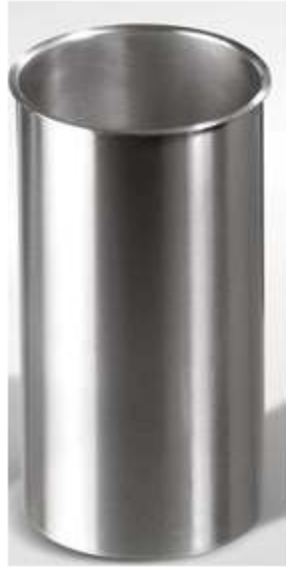
company. Given the aim of the present study regarding evaluating the cylinder liner of the agricultural tractor, the cylinder liner of the Perkins 4-248 engine was selected, which was associated with the Massey Ferguson 285 tractor. Fig. 1 depicts a sample of this cylinder liner.

Fig. 1. A sample of the cylinder liner

The measured cylinder liner material involves high quality cast iron (GG 25) which has 101 mm bore diameter and 233 length. The chemical compositions of the grey cast iron are shown in Table 1. The inner surface of cylinder liners has a hardness of 225-272 HB. The metallography (ASTM A247) results indicated that the liner consists of cast iron along with the pearlite matrix and an insignificant amount of the steadite (iron phosphide eutectic network). Further, the form of graphite is type I, graphite distribution is pattern A, E and graphite size is 4,5.

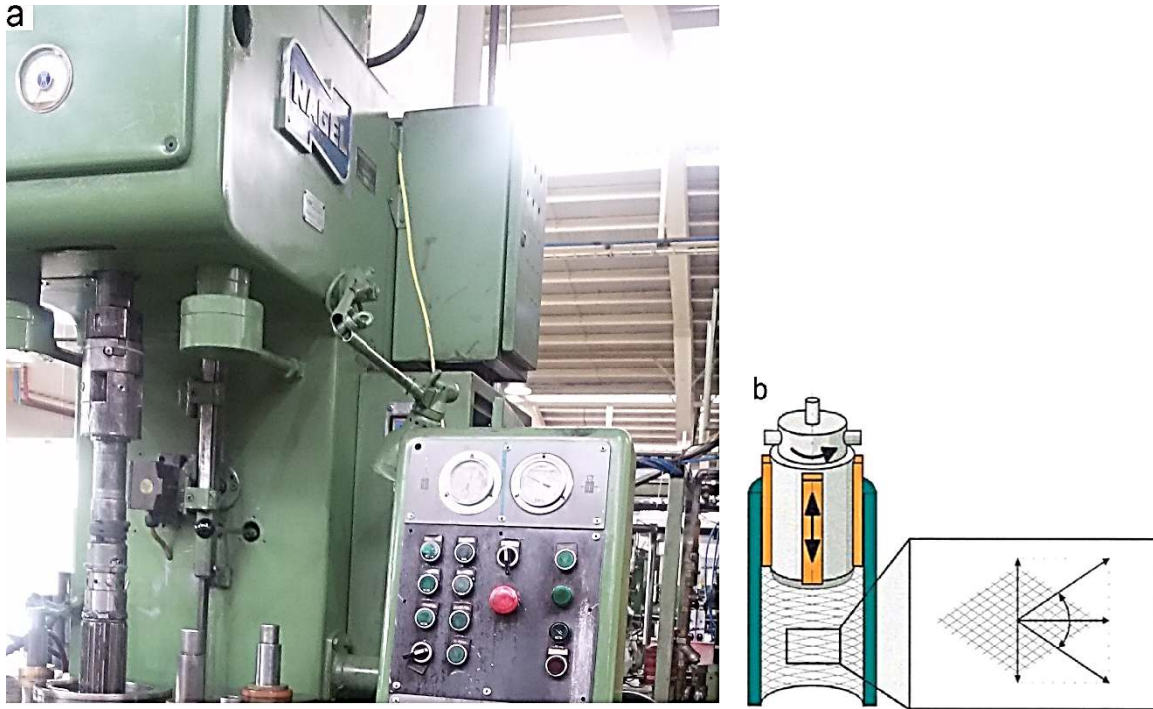
First, the honing process from cylinder liners in the Perkins 4-248 engine block honing station was used for producing specimens by utilizing a mono spindle vertical honing machine by a developed instrument (NAGEL no. 28-8470)(Fig. 2). Cylinder blocks are delivered to the honing station after pressing and boring liners in the machining line. Then, liner specimens were prepared with varied honing depths, representing a surface roughness of 0.05, 0.15, 0.25, 0.5, and 0.8 μm in R_a (Fig. 3). In addition, five honing marks were produced to assess the impact of the honing mark on the wear and friction related to the contacting surfaces. The final surface of engine liners in plateau honing should become 0.8 μm in R_a (in other words R_k 3.712, R_{pk} 0.895, and R_{vk} 2.321 values should be seen on the final surface) on the surface processed by long-stroke

Fig. 2. (a) Vertical honing machine with an expansible tool and (b) Schematic representation of a honing head and its motion.

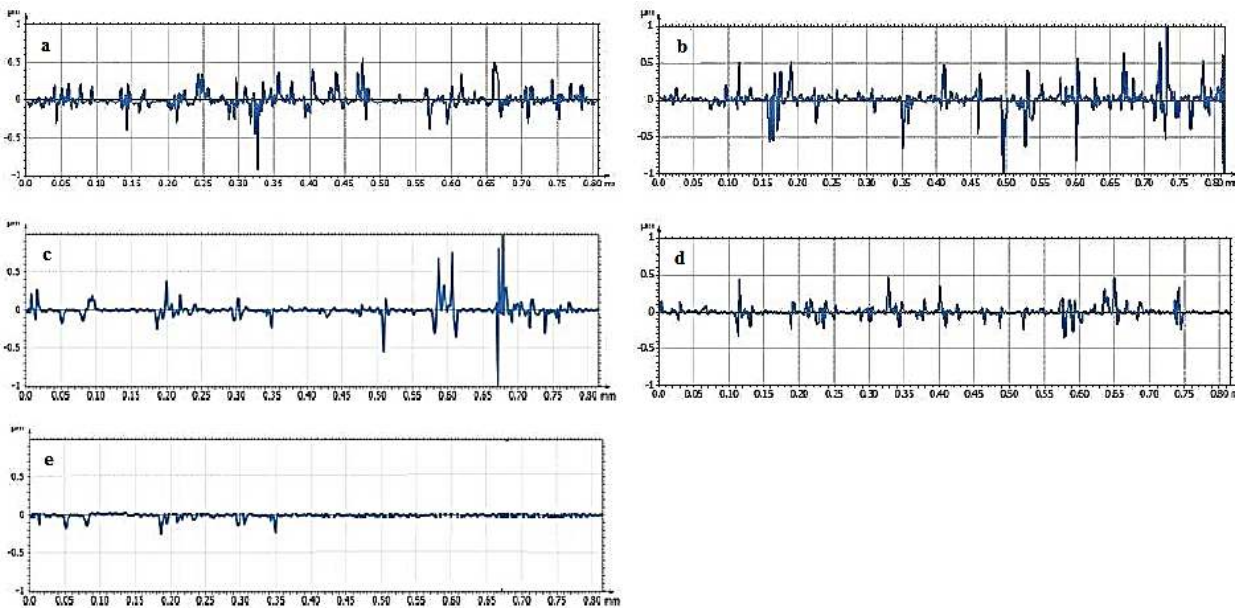
Fig. 3. Honing processed surface roughness: (a) R_a 0.8 μm , (b) R_a 0.5 μm , (c) R_a 0.25 μm , (d) R_a 0.15 μm , and (e) R_a 0.05 μm —polishing processed surface

honing. Additionally, two surfaces were created by random grinding without any honing marks, and the surface roughness of which were 0.15 and 0.25 μm in R_a . Next, all liner specimens were mounted on a reciprocating tester along with cleaning with acetone. Finally, scanning electron and optical microscopes were utilized to examine worn tracks on surfaces.

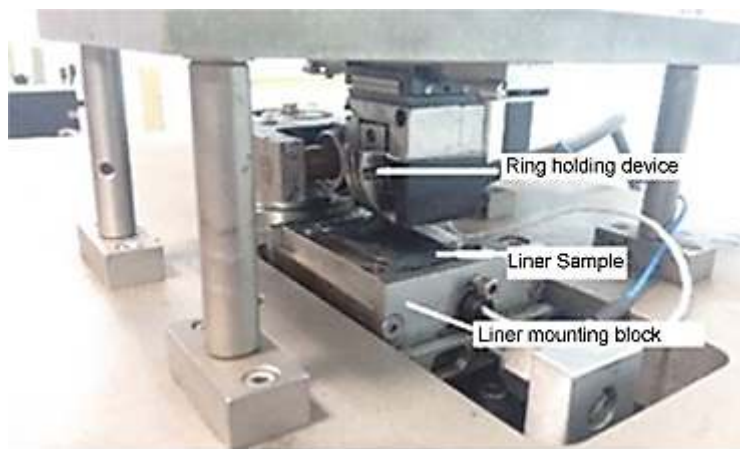
A reciprocating ring-liner tribometer driven by a slider-crank mechanism with a stroke length of 80 mm (Fig. 4) was implemented for evaluating the friction and wear characteristics of cylinder liner surfaces with different honing marks against piston ring surfaces with 27 ± 2 °C temperature. Then, the contact surface was lubricated by using a10W40 semi-synthetic oil (μ_D equal to 0.08 Pas at 40 °C). It should be noted that the total wear test took 120 min in which extra amounts of lubricant were summed (2-3 mL) every 20 min. In addition, the normal force and engine velocity used for these tests were 100 N and 120 rpm, respectively (Yousfi *et al.*, 2015; Kim *et al.*, 2018b).

Fig. 4. Reciprocating ring-liner tribometer

Friction tests undertake a load level of 100 N and reciprocating velocity of 120 rpm (Yousfi *et al.*, 2015; Kim *et al.*, 2018b). The contact pressure is high and can reach up to 50 MPa thanks to a small contact surface between the liner and ring surface (nearly $2\text{-}3\text{ mm}^2$). Then, the friction was measured after 0, 15, 30, 60, and 120 min. Finally, the friction coefficient was calculated by applying the ratio between the average normal force (F_N) over the mean tangential force (F_T) assessed by strain gauges. The Rtec Multi Function Tribometer software was used. A balanced Wheatstone bridge has been constructed by mounting four strain gauge over F_T . Two strain gauges have been mounted over outer surface (for F_N), while rests are placed at inner surface.

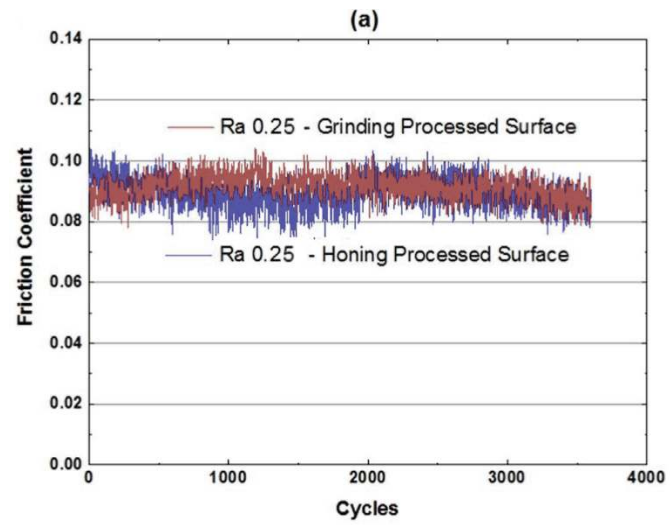
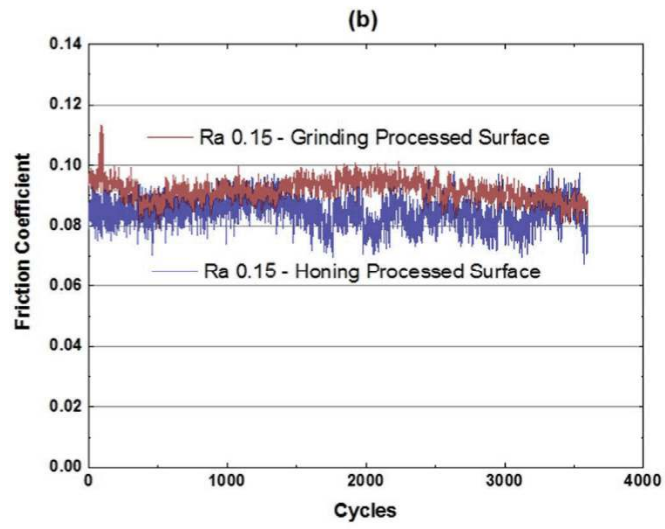
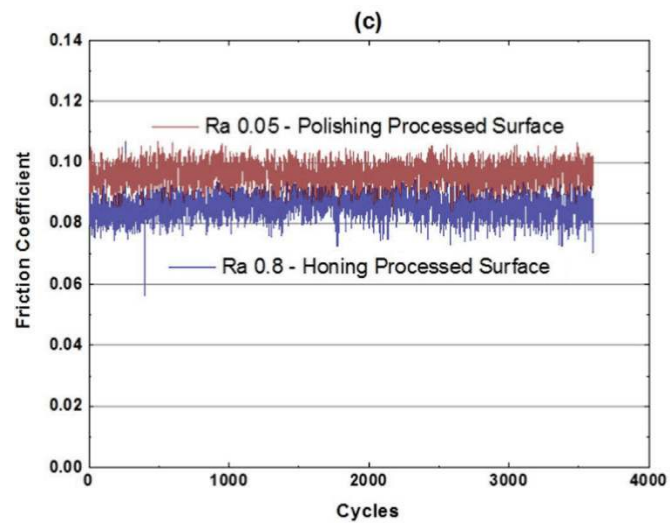
Fig. 5 illustrates the specimen friction coefficient made by utilizing different surface processes. As displayed, compared to the surfaces with a grinding process with similar surface roughness, honing processed surfaces involve the coefficients with lower friction. Based on the results, no difference was observed in the friction performance related to the surface roughness of $0.8\text{ }\mu\text{m}$ in R_a in comparison to those of smoother surfaces. However, the highest friction coefficient was reported for polishing processed surfaces which confirmed some numerical results in the mixed lubrication regime (Mezghani *et al.*, 2013; Yousfi *et al.*, 2014). However, these findings should be approved by firing engine experiments which consider real engine conditions. These findings corroborate with those of Yousfi *et al.* (2015), Kim *et al.* (2018b), Anderberg *et al.* (2018), and Grabon *et al.* (2018).

Fig. 5. The friction coefficient related to surface roughness: (a) R_a 0.25 μm , (b) R_a 0.15 μm , and (c) R_a 0.8 and 0.05 μm

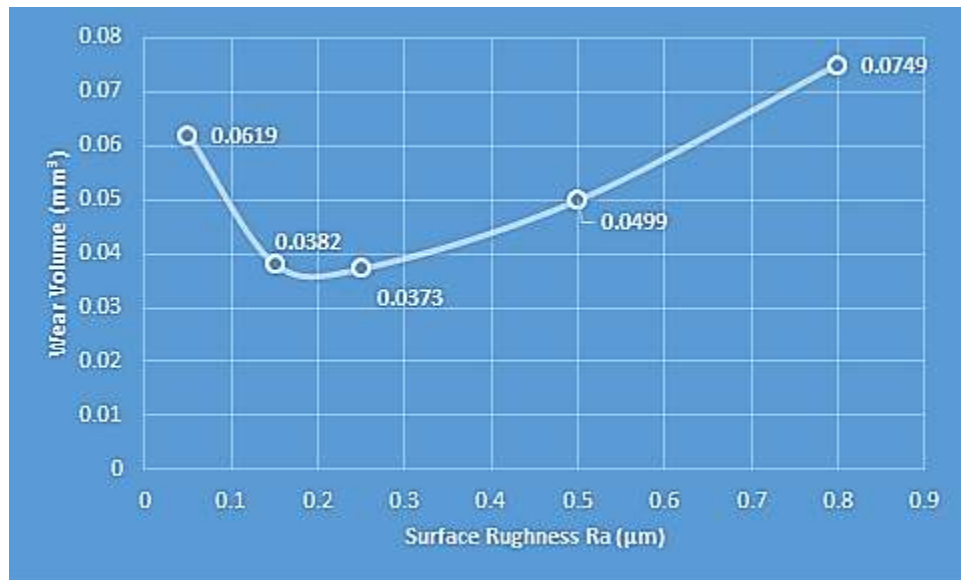
The evaluation method related to the wear volume of the cylinder liner during the plateau honing process compares the surface bearing as a curve of the original and plateau honed surface (Kumar *et al.*, 2000; Srivastava *et al.*, 2007). Further, this method represents that original surface depth is not eliminated when there is a negligible amount of wear. Fig. 6 illustrates the wear volumes related to cylinder liners with different roughness of surface. The least volume of wear is created by the surfaces with the honing marks of 0.1-0.2 μm in R_a . However, the highest wear volume was observed in the surface roughness of 0.8 μm in R_a . Based on the results, the volumes of wear increased by enhancing the surface roughness from 0.2 μm since colliding jagged asperities resulted in increasing in polishing effects. Contrarily, a decrease in the surface roughness from 0.1 μm led to an increase in the volumes of the wear by considering the fact that an increase in the real contact area between steel ball and cylinder liner results in creating more severe wear by adhesion. Other studies such as Yousfi *et al.* (2015) and Kim *et al.* (2018b) reported a similar trend for the wear volumes related to cylinder liners with different surface roughness.

In addition, the randomly ground surface indicated identical or better wear resistance after comparing the wear volumes related to the two machined surfaces, in comparison to the honing processed surface. It is worth noting that the surface valleys interrupt the maintaining hydrodynamic pressure of the lubricant film which results in creating partially metal-to-metal contact and plastic deformations by interacting asperities.

Fig. 6. Wear volume of the cylinder liner

As shown in Fig. 8, the surface with $R_a\ 0.8\ \mu\text{m}$, which involves deeper grooves and a less contact area, demonstrates severe plastic deformations due to the interaction existing in colliding asperities. Based on the results, the grooves smeared by sliding surface and plastic deformations became smooth. Kim *et al.* (2012) evaluated the effect of reserving oils on grooves as well. The results of the current study further represented that surfaces with $R_a\ 0.25$ and $0.15\ \mu\text{m}$ still indicate several groove patterns after the sliding test. Furthermore, adhesive wear was observed by the smoothest surface with polishing, which produced higher volumes of wear (Fig. 6). Thus,

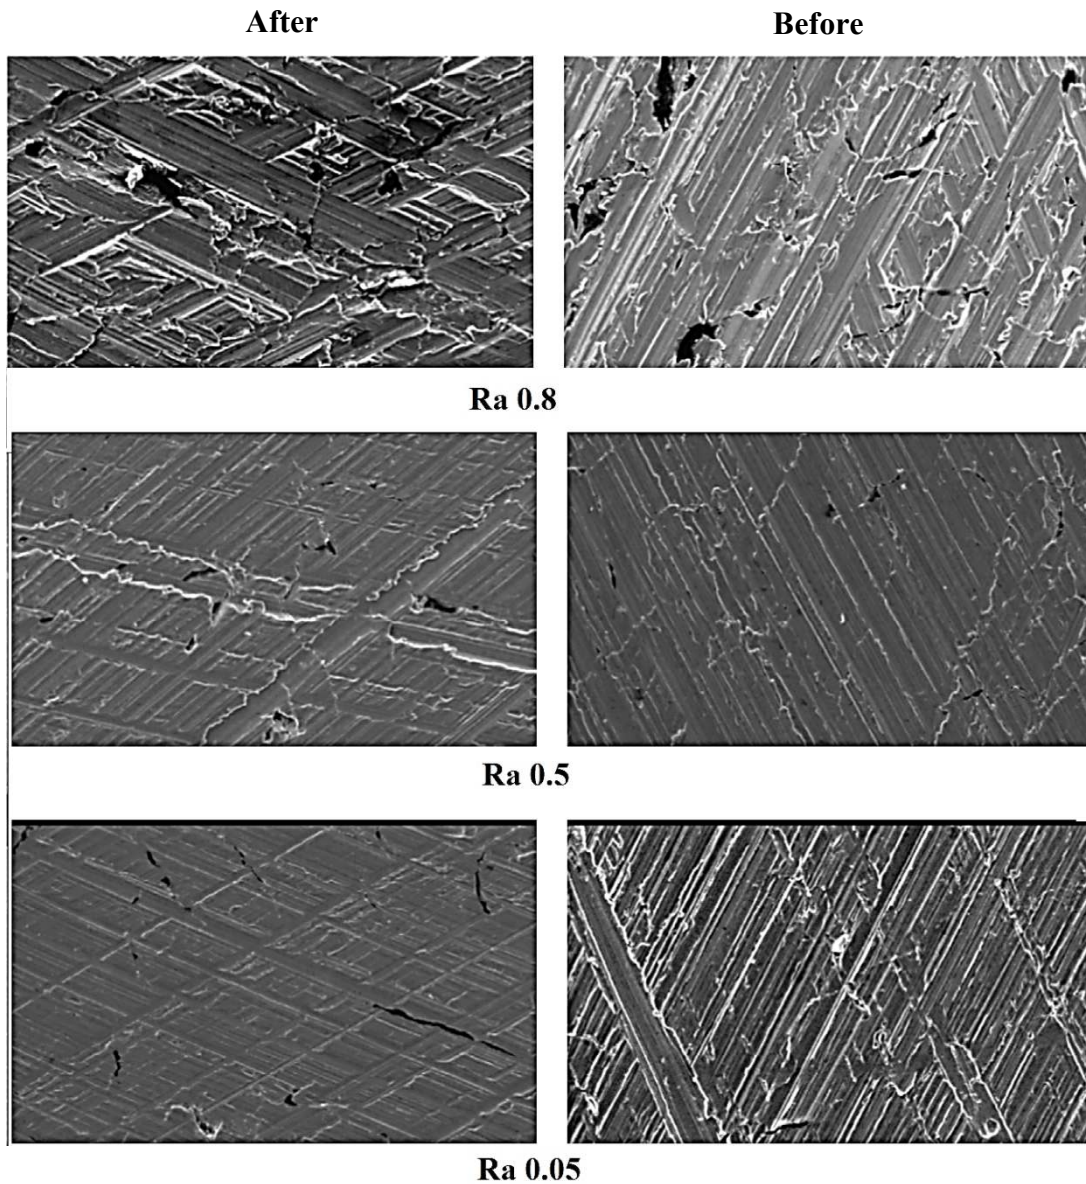
To evaluate the effect of the honing mark on the wear, the honed surfaces with different surface roughness were considered for comparison. As shown in Fig. 7, the rough surface with 0.8 μm in

Ra is rather damaged due to its plowing action and deep valley. In addition, the polished surface indicated a deep wear depth and higher plowing, while the wear mark related to the surface roughness of $0.5\ \mu\text{m}$ in R_a is less than those of other surfaces.

Fig. 7. Microscopic images before and after the experiment

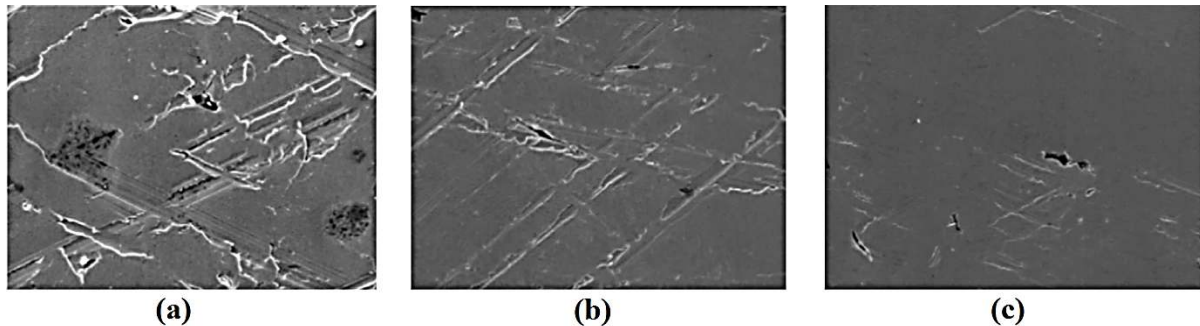
there is an optimum range of surface roughness for the purpose of reducing the wear amount of the plateau honing process ranged between 0.15 and 0.25 μm in R_a .

Fig. 8. SEM images analysis of honing processed surface: (a) R_a 0.8 μm , (b) R_a 0.25 μm , and (c) R_a 0.15 μm

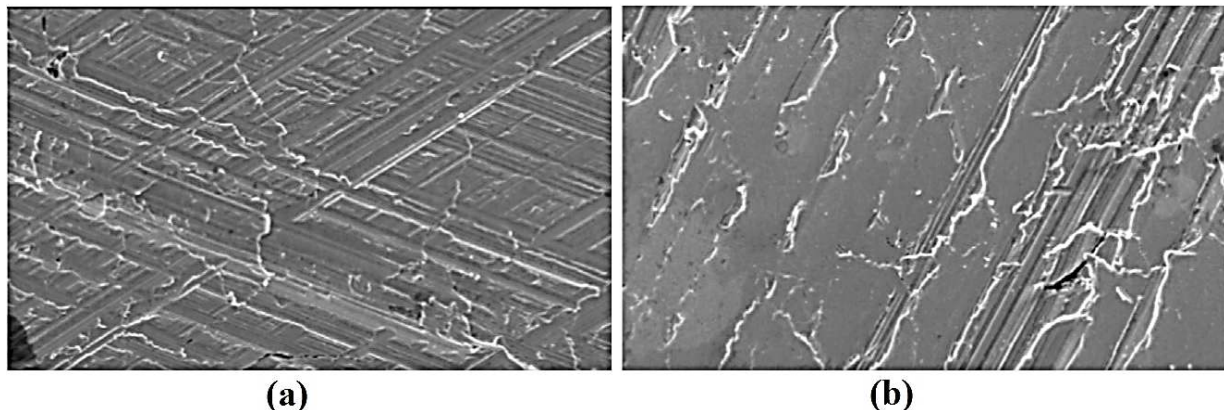
Fig. 9 depicts SEM images measured by ground surfaces without any honing process. The amounts of the wear were almost similar in comparison to similar surfaces with honing. Although the optimum groove depth of plateau honing is available for reducing the amounts of wear, the effect of the groove by using the plateau honing process which is considered as an oil reservoir is insufficient for reducing the wear compared to using only the grinding process.

Fig. 9. SEM images analysis of grinding processed surface: (a) R_a 0.25 μm and (b) R_a 0.15 μm
