Corrosion Performance of Steel Rebars in the Roof of a 65-Year-Old Underground Reinforced Concrete Water-Storage Tank

Abstract: This work deals with the corrosion evaluation of steel rebars in an underground water-storage tank using visual inspection, half-cell potential, and electrochemical impedance spectroscopy (EIS). The studied case has a service life of 65 years. From the inside, red stains were observed on the roof of the tank, and some cracks, as well as spalling of the concrete's cover, raised suspicion of corrosion damage. Twenty-seven points on the tank's roof were selected to drill out cores for further investigation. Measurements of the chloride penetration in the roof showed that the bottom part of the roof that was exposed to greater humidity and chloride-laden vapor was at risk of heavy corrosion. EIS studies of the steel rebars at different depths confirmed that those located in the upper part of the roof still have appropriate resistance to corrosion, but the lower ones exhibited a high corrosion rate. As a result, a repair of at least 12 cm in depth of the bottom of the roof and the installation of a proper ventilation system inside the tank were recommended. DO

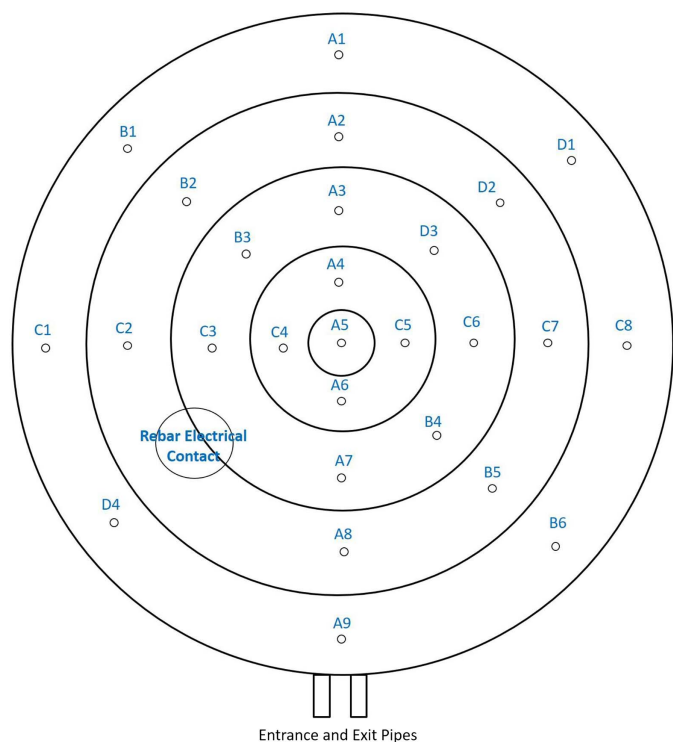
Fig. 3. Location of the drilled cores.

^aThe locations of the drilled spots on the roof surface are depicted in Fig. 3.

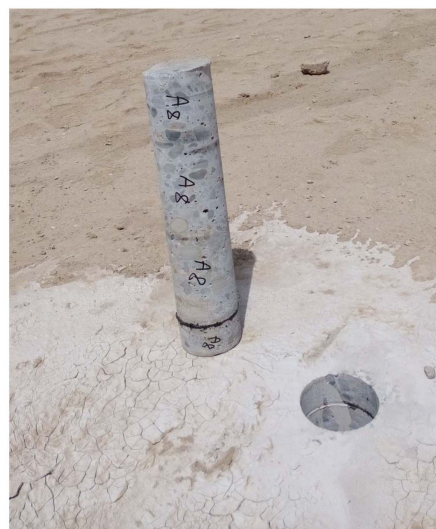
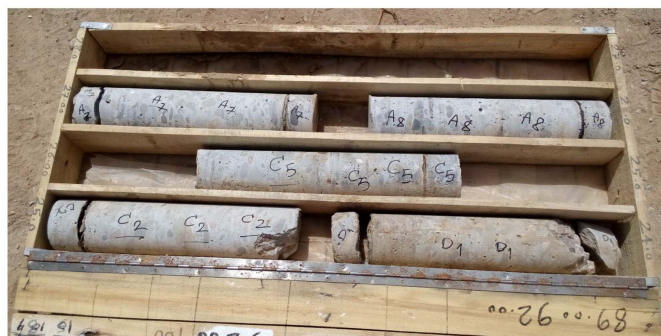
Fig. 4. (a) Typical cylindrical core; and (b) delivery box of the cylindrical cores. (Images by authors.)

To determine the corrosion performance (steel rebars) of the tank, a preliminary visual survey of the structure was carried out both from the ground and underground, to assess visible signs of damage. Afterward, to inspect and evaluate the corrosion performance (corrosion degree, corrosion rate, and serviceability) of the steel rebars, 27 locations on the roof were selected and cylindrical cores (with diameter of 15 cm) were drilled out and delivered in boxes open to the air for further laboratory investigations. These investigations were performed one day after the drilling process. Locations of the cores were chosen to be a reasonable representation of the entire roof surface. Locations of the cores are shown in Fig. 3. Then, the cores (Fig. 4) were sent to the laboratory for further investigation.

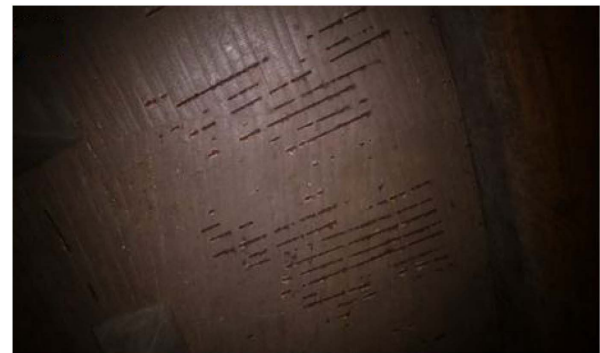
There is no ventilator to extract the humidity and chloride-laden vapor from the tank. The overflow room, which is the only possible way to exhaust the humidity and chloride vapor, had been sealed for several years. Therefore, the relative humidity in the tank was measured at 90%. The high humidity and lack of exhaust of the chloride vapor made the structure of the tank vulnerable to corrosion damage. Red stains were observed in almost the entire inside surface of the roof. The concrete cover, which was reported to be 4 cm, fell short in many places and corroded steel rebars appeared clearly [Fig. 7(a)]. The piping system was also severely corroded, as seen in Fig. 7(b). Because of the ingress of corrosion products into the concrete and their volume expansion, many cracks were also observed on the roof from the inside (concrete cover) of the tank.

Fig. 7. (a) Concrete cover removed exposing corroded steel rebars at the roof surface of the reservoir; and (b) severe corrosion in the pipeline system. (Images by authors.)

mechanical properties such as strength and ductility (Cairns et al. 2005). It can also have strong effects on the adhesion of the steel rebars to concrete. In addition, rust products, which have a larger volume than the original steel, create splitting stresses acting on the concrete, leading to cracking and consequently spalling of the concrete cover (Tahershamsi 2016). In conclusion, it can be stated that the bottom part of the roof (at least up to 12 cm) should be repaired as soon as possible because of corrosion damage and an appropriate air-conditioning system should be installed to delay the corrosion damage caused by the chloride vapor.
