Evaluation of Grout Curtain Performance and Seepage Behavior in Doosti Dam, Iran

Hamid Saeidi¹, Mohammad Ghafoori^{2*} and Gholamreza Lashkaripour²

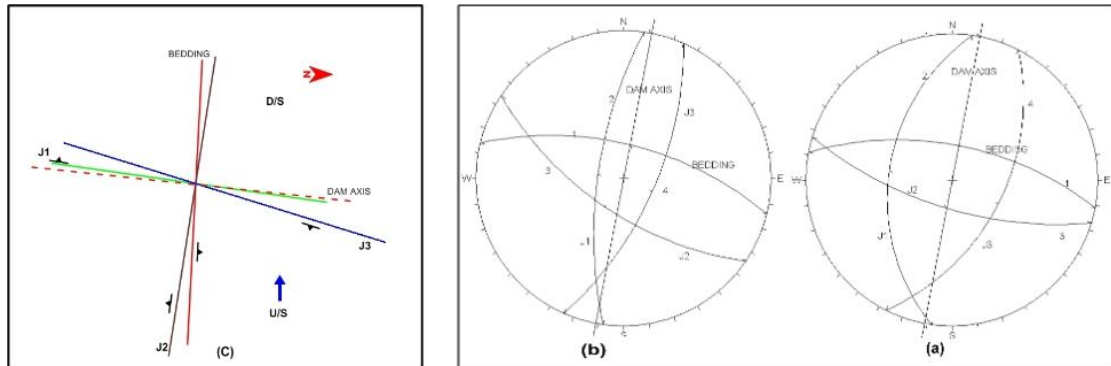
Figure 3. Geometrical properties of discontinuities in dam site (a) right side (b) foundation & left side and (c) discontinuities position with dam axis

The assessment of geometrical properties of discontinuities indicate that the bedding strike (E-W) is approximately perpendicular to the dam axis (N-S) and the bedding dip is directed toward the right side (NE). Bedding has the highest potential in water transmission from the dam lake to the downstream. Joint sets J1 and J2 have seepage potential as well. A comparison among the properties of discontinuities surfaces shows that these properties are similar to each other. Most of joints surfaces are smooth, mostly without filling and oxidized. Silt and clay are the major filling materials followed by calcite and gypsum. Their continuity is medium to high (3-10m) and their openness is less than 2.5 mm. Structural condition of joints and bedding surfaces in the dam site is presented in figure.3.

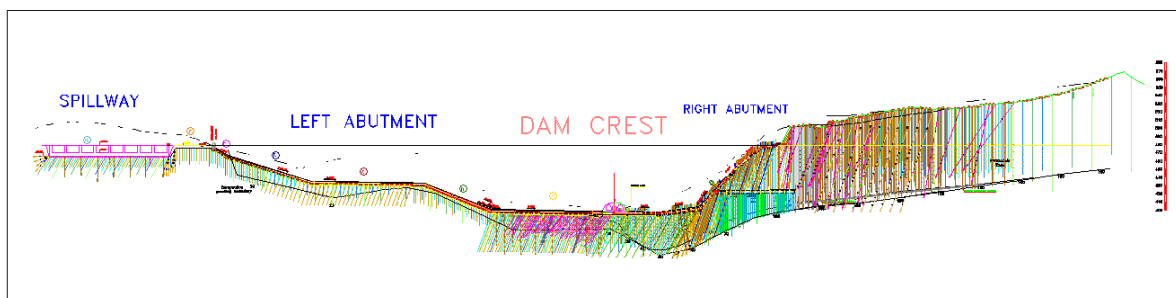
Figure 5. Grout curtain borehole arrangement in doosti dam (culham co. 1999)

Construction of grout curtain by injection is one of the common methods of maintaining the hydraulic stability of earth dams to prevent leakage and internal erosion of dam foundations. Grout curtain of Doosti Dam is 1125 m long, from which 335 meters is in right abutment and open space, approximately 225 m in the foundation or bedrock and 535 m in the left abutment to the end of spillway entrance platform. Specifications and longitudinal section of Doosti Dam grout curtain are presented in Table 3 and figure 5 respectively.
