# Repair of Damaged Steel-Concrete Composite Girders Using Carbon Fiber-Reinforced Polymer Sheets

**Abstract:** The aging infrastructure of the United States requires significant attention for developing new materials and techniques to effectively and economically revive this aging system. Damaged steel-concrete composite girders can be repaired and retrofitted by epoxy bonding carbon fiber-reinforced polymer (CFRP) laminates to the critical areas of tension flanges. This paper presents the results of a study on the behavior of damaged steel-concrete composite girders repaired with CFRP sheets under static loading. A total of three large-scale composite girders made of W355×13.6 A36 steel sections and 75-mm-thick by 910-mm-wide concrete slabs were prepared and tested. One, three, and five layers of CFRP sheet were used to repair the specimen with 25, 50, and 100% loss of the cross-sectional area of their tension flange, respectively. The test results showed that epoxy bonded CFRP sheet could restore the ultimate load-carrying capacity and stiffness of damaged steel-concrete composite girders. Comparison of the experimental and analytical results revealed that the traditional metho

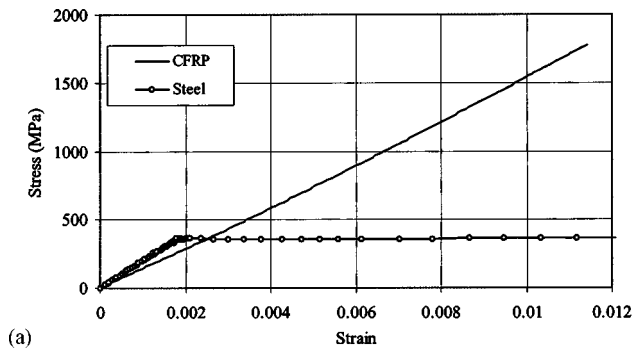
**Fig. 1.** Typical stress-strain behavior: (a) CFRP and steel; (b) concrete

16 straight strips (coupons) with a length of 400 mm and a width of 25 mm, an average tensile strength of 2,137 MPa, a tensile modulus of elasticity of 144.0 GPa, and a Poisson's ratio of 0.34 were obtained. A typical stress-strain plot for CFRP coupons tested in uniaxial tension is shown in Fig. 1(a).

Concrete was ordered from a ready mix plant with nominal compressive strengths of 15.5 and 27.5 MPa, slump of 100 mm, and maximum aggregate size of 10 mm. Twenty 75×150 mm cylinders were made at the time of castings and were kept with the girders during curing. They were tested under uniaxial compression right before the beam tests. The compressive strength and modulus of elasticity of concrete were 16.6 and 29.1 MPa and 13.8 and 19.3 GPa, respectively. Typical stress-strain plots of the concrete with two different compressive strengths under uniaxial compression test are shown in Fig. 1(b).

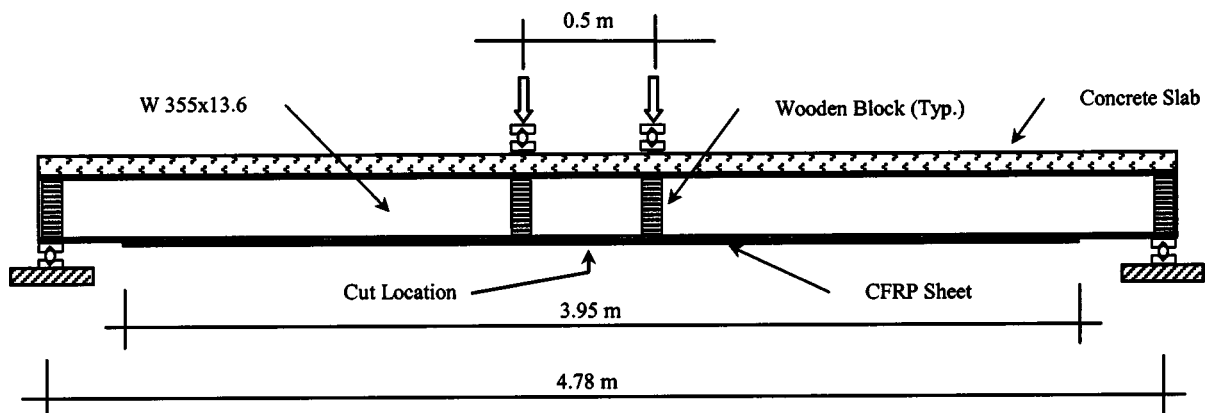
Fig. 5. Schematic of loading setup

The clear span was 4.78 m and the loading points were 0.5 m apart, as shown in Fig. 5. The loading points and supports were made using rolling blocks, and one sphere blockhead was used to transfer the load from the hydraulic jack to the spreader beam. The test setup is shown in Fig. 6.

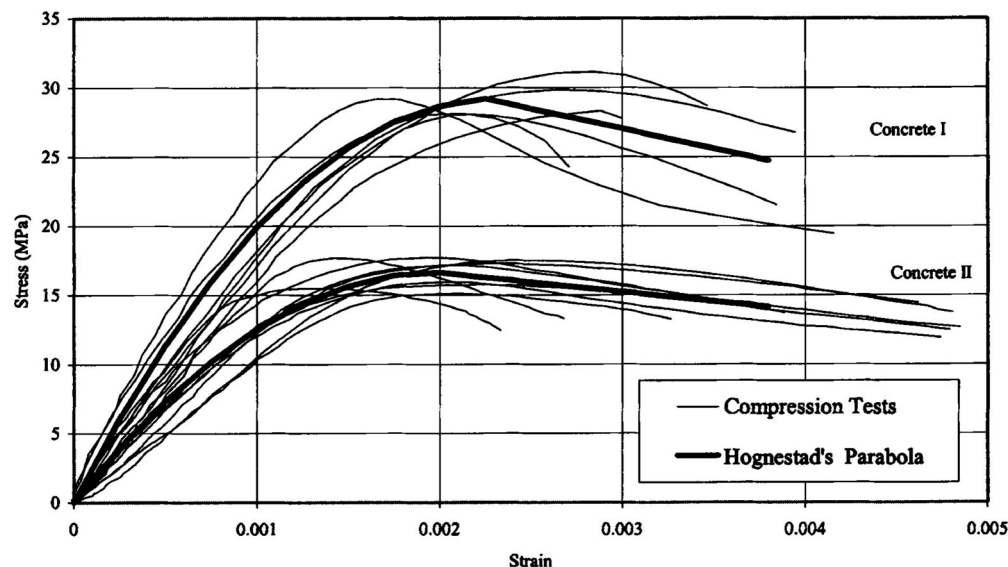
**Fig. 7.** Constitutive modeling of concrete with different strengths (I: 16.6 MPa; II: 29.1 MPa)

Uniaxial tension and compression tests were performed on the materials in order to obtain their constitutive properties. The results of these tests are listed in Table 1. The stress-strain plots for the concrete with two different compressive strengths and the corresponding Hognestad's parabolas are shown in Fig. 7.

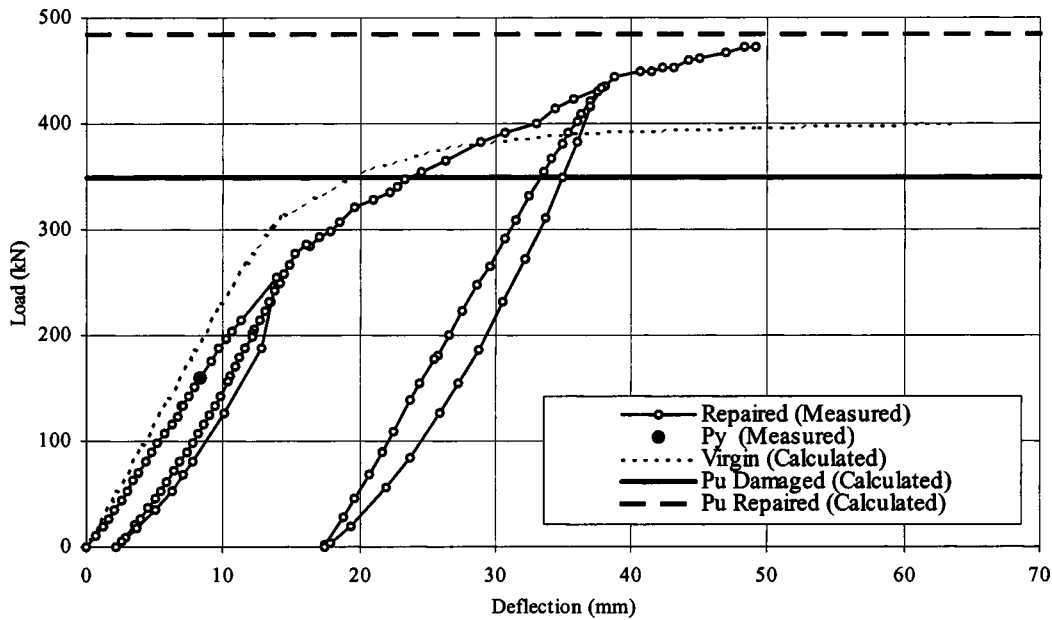
Fig. 10. Load versus deflection of girder with 25% loss in flange area and repaired with one layer of CFRP sheet

The load-deflection behavior of the repaired composite girder with 25% loss in the flange area is shown in Fig. 10. The concrete slab had an average compressive strength of 29.1 MPa. The girder showed a fairly linear response to the load from the beginning. During the unloading cycle in the elastic region (not shown), no sign of permanent deformation and nonlinearity was observed. The elastic stiffness of the girder was 19.6 kN/mm. The bottom flange of the girder started to yield at the 166.6 kN load level. The CFRP sheet was under a tensile stress of 170.3 MPa, equal to 8% of its ultimate strength at that point. Proceeding into the postelastic region, the girder was twice unloaded and reloaded. The elastic stiffnesses of the first and second reloading segments were 21.5 and 22.0 kN/mm, respectively. The girder continued to carry the load with a plastic stiffness of 6.7 kN/mm. At the 449.5 kN load level, the CFRP sheet started to show signs of failure (i.e., snapping of the edge fibers) while it was carrying 2,045 MPa, equal to 96% of its tensile strength. The girder failed at 471.8 kN and an ultimate deflection of 49 mm. The ultimate tensile stress in CFRP

was 2,298.0 MPa, 7.5% above its average tensile strength. Ultimate compressive strain in the top of the concrete slab reached 0.0018, which is very close to the peak strain value. The sign of extreme deformation at the tip of the cuts was visible and the tension flange at one of the cut tips ruptured 20 mm long, after failure. A few longitudinal cracks were observed in the concrete slab, but they did not have any effect on the result due to their limited width. At the midspan, between two loading points, the web and flanges displayed clear shear plane due to yielding, but there was no buckling and crippling. In other words, the concrete slab and wooden blocks stayed effective in supporting the compression flange and web up to failure. The CFRP sheet tension failure mode was very similar to the one in the uniaxial tension tests. The sheets burst into several narrow and long needle shape pieces attached to the girder at their ends.

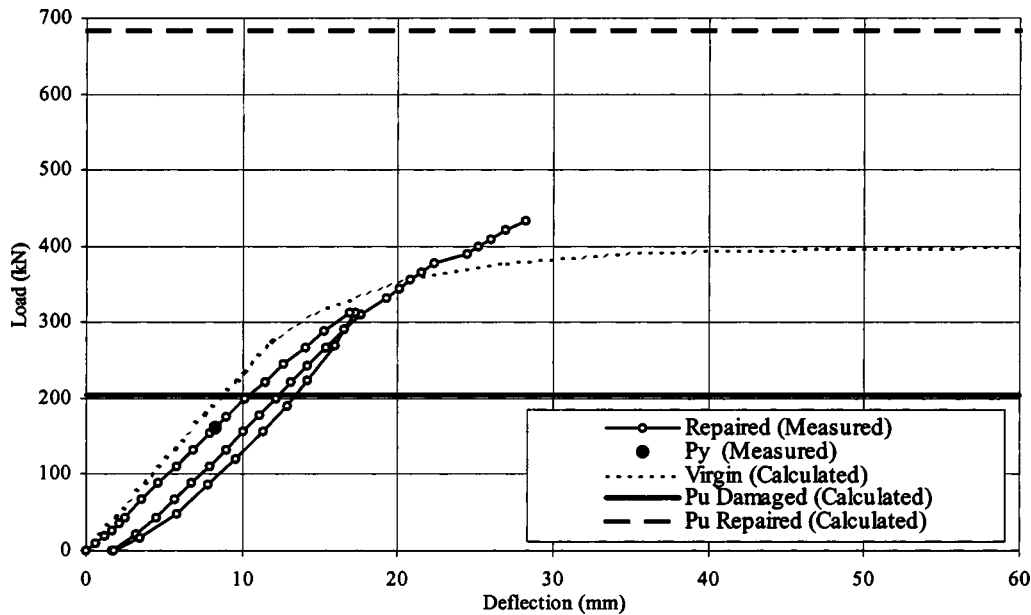
Fig. 12. Load versus deflection of girder with 100% loss in flange area and repaired with five layers of CFRP sheet

strain in the flange directly. Therefore, two strain gauges on the web at midspan were used to obtain hypothetical values of strain in the bottom of the flange. The load-deflection behavior of the repaired girder is shown in Fig. 12. The girder started carrying the load with a fairly linear response. The elastic stiffness of the girder was 19.9 kN/mm and, during the elastic unloading (not shown), there were no signs of permanent deformation or stiffness change. At 133 kN, the epoxy that filled the cut separated from the steel. The linear response continued up to the 162.2 kN load level, at which an extrapolated prediction of the strain at the bottom face of the tension flange reached the yielding strain. The CFRP sheet stress was 194.4 MPa, equal to 9% of its ultimate strength. Continuing loading, the longitudinal cracks appeared at 287 kN and a complete unloading and reloading was performed at 300 kN. There was minimal hysteresis in the loop and the loop closed out at the point that unloading had started. The reloading stiffness was 20.1 kN/mm, very similar to the stiffness at the initial loading. After reaching the load level of 311 kN, the plate started to debond from the steel girder at the cut location in the midspan. Approaching the load level of 380 kN, the failure signs of the CFRP ends were noticed. The girder failed at the load level of 434 kN, due to sudden and complete debonding of the CFRP sheets (initiated from the end) and subsequently rupture of the steel web and failure of the concrete. At the peak load, the CFRP laminate was carrying an 840.1 MPa tensile stress, equal to 40% of its strength, and the concrete strain was 0.0016, well below its failure point. The compression flange and the web did not show any sign of instability due to the support provided by the slab and the wooden blocks in the entire experiment.
