Pitting Corrosion of 17-4PH Stainless Steel: Impingement of a Fluid Jet vs. Erosion–Corrosion in the Presence of the Solid Particles

Abstract

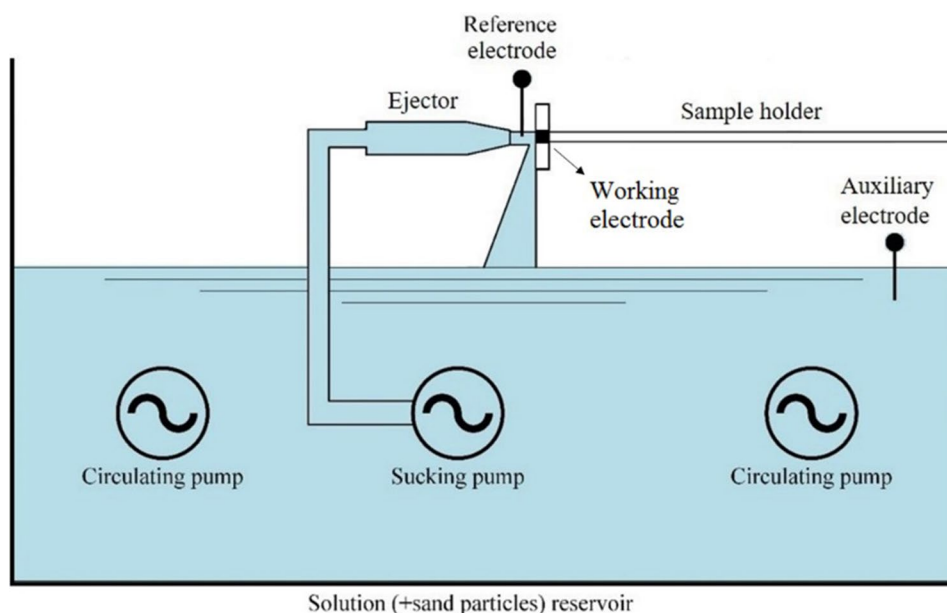
Fig. 1 The schematic diagram of EC apparatus used in this work. Two circulating pumps were homogenised the slurry and the medial one pumped the slurry up towards the working electrode surface. Reference electrode was situated frontward the ejector in contact with the slurry and auxiliary electrode was placed somewhere in reservoir

All EC tests were performed by an apparatus of impinging jet which has been illustrated in Fig. 1, schematically. The apparatus was designed based on Zu, Hutchings and Burstein's work [31] with some differences in feeding the sand particles. The reservoir commonly contained 15 L of the test solution and was open to the air. Two pumps were used to circulate the test solution in order to attain homogeneity and prevent the sand precipitation. Another discrete sucking pump was utilised to drive the solution up to the PVC nozzle (5 mm) by means of a hose. All parts of the pumps were made of non-metallic equipment. The impinging jet direction was perpendicular to the specimen surface. The distance between the nozzle exit and the working electrode was 10 mm. The impact velocity was calculated by dividing the discharge rate of water by the cross-sectional area of the nozzle. In this way, the mean impact velocity was calculated as 3 m/s. The concentration of the particles in the slurry was determined by weighing a given volume of collected slurry for a constant period of time (ca. 3 wt%).

To investigate the electrochemical behaviour of 17-4PH (H900) SS under the EC condition, the classic three-electrode designation with the saturated calomel reference electrode (SCE) and platinum counter electrode was used. The situations of the electrodes have been shown in Fig. 1.

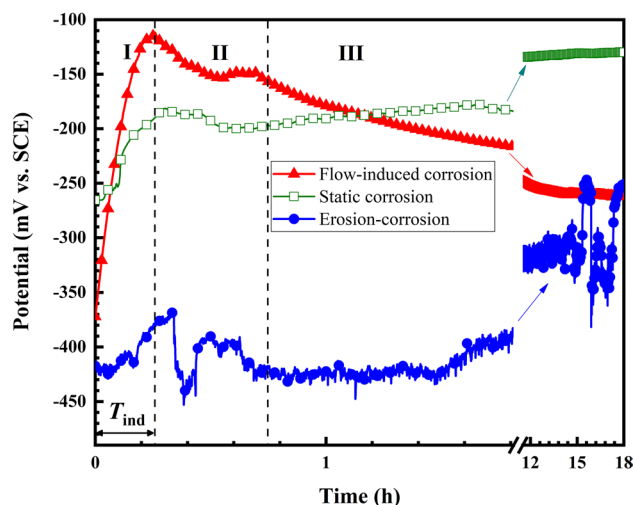
Fig. 2 Open-circuit potential measurements under the SC, FIC and EC conditions

The OCP in the three studied conditions is depicted in Fig. 2. Recording started right after the sample was exposed to the test solution.

Three distinct regions that are believed to exist in the FIC state [8] are observed here as well. First, the region with increasing potential trend which has been established by accelerated passive film formation. Following this ascendant trend, the significant potential drop is occurred at the border between regions one and two. This potential drop can be attributed to the formation of stable pit on the surface after induction time (T_{ind}). Furthermore, in the second region, there are some fluctuations initiated by metastable pits nucleation, growth, and repassivation. At third region, by further stabilisation of the pit, the E_{corr} decreases smoothly and reaches to a value of about -270 mV (SCE).

Regarding to SC, the OCP starts from -250 mV (SCE) and gradually reaches to about -140 mV (SCE). However, the OCP for the EC begins at much lower value of about -420 mV (SCE) and slowly goes up to about -300 mV (SCE). There are also a lot of fluctuations representing the

depassivation events caused by the solid particle impacts. In contrast to FIC, the general trend of potential for SC and EC conditions is increasing.

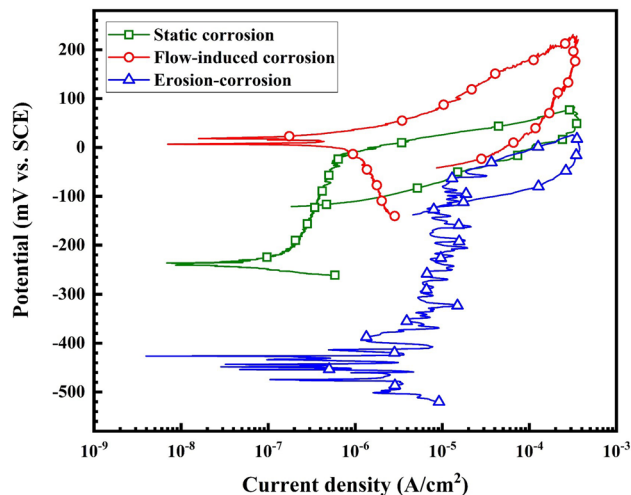
Fig. 3 Potentiodynamic curves obtained in the SC, FIC and EC conditions.

Figure 3 illustrates the potentiodynamic curves obtained in different conditions. As it can be observed, in 3.5 wt% NaCl solution, 17-4PH (H900) SS remains passive in the SC and EC conditions, while in the case of the FIC, there is no evident passivity and sample indicates active state. This behaviour ascertains the presence of stable pit on the surface. Clearly, there are more transients standing on anodic

branch of the EC curves compared to the other two. As mentioned, these transients are representing the depassivation events caused by the impact of the sand particles. In addition, the cathodic branch related to FIC condition is larger compared to other condition. This behaviour may arise from the unstable condition formed by pitting corrosion.

According to Fig. 3, it is clear that three distinct parameters must be taken into consideration in these different conditions including the pitting potential (E_{pit}), the corrosion potential (E_{corr}), and the passivity range.

Figure 4 compares the passivity behaviour at the potential of -150 mV (SCE) for the SC and EC conditions. At this specific potential, 17-4PH (H900) SS would be passive in 3.5 wt% NaCl solution under the two mentioned conditions, while in the case of the FIC, there is no state of passivity for this alloy, see Fig. 3.

The results represented in Figs. 3 and 4 confirm that the i_{pass} is increased and the E_{pit} is reduced by EC. These results are in line with previous reports that the erosion caused by solid impacts can lead to the increase of the current recorded by the potentiostat as a result of the surface denudation and also to the reduction of E_{pit} [17]. The higher passive current density can be attributed to the continuous deterioration of the passive layer caused by solid particles. Furthermore, SEM micrographs after EC measurement show a surface with high roughness in contact to the corrosive environment, see Fig. 5. Evident plastic deformation traces in these micrographs divulge the numerous local depassivations caused by solid particle impacts. They confirm that in the presence of the solid particles, the passive surface is repeatedly deteriorated. Besides, it is evident that how the surface is roughened by the impact of the solid particles. It is well known that both the pit nucleation and growth processes are promoted by increasing the surface roughness [15, 18]. Thus, E_{pit} is reduced by the solid particle impacts on the surface, compared to when the condition is static.

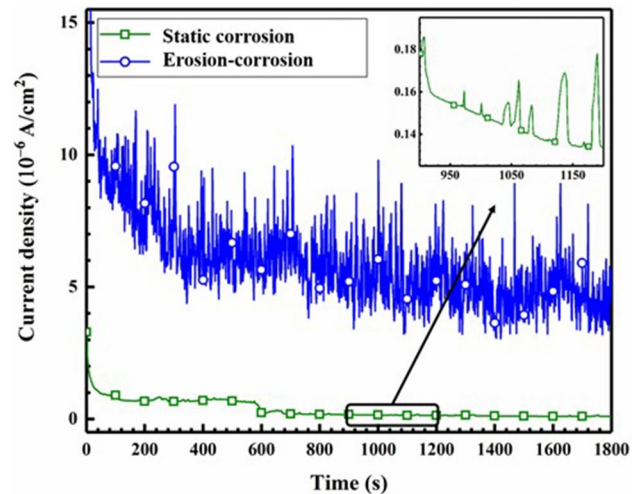
Fig. 4 Typical potentiostatic experiments under SC and EC conditions

As shown, the i_{pass} in the EC state is significantly higher compared to SC and there are abundant transients in current. The substantial difference in the size and density of the existing fluctuations under the SC and EC conditions can be noticed better by considering the magnified section. The current transients on the EC curve are nearly 100 times larger than SC ones. As abovementioned, the depassivation events caused by collision of the solid particle to the surface can originate these abundant transients. However, the fluctuation of the current density in SC condition originates from metastable pitting [32, 33]. During measurement, the background current density is reduced by healing of the passive layer on the surface [34].

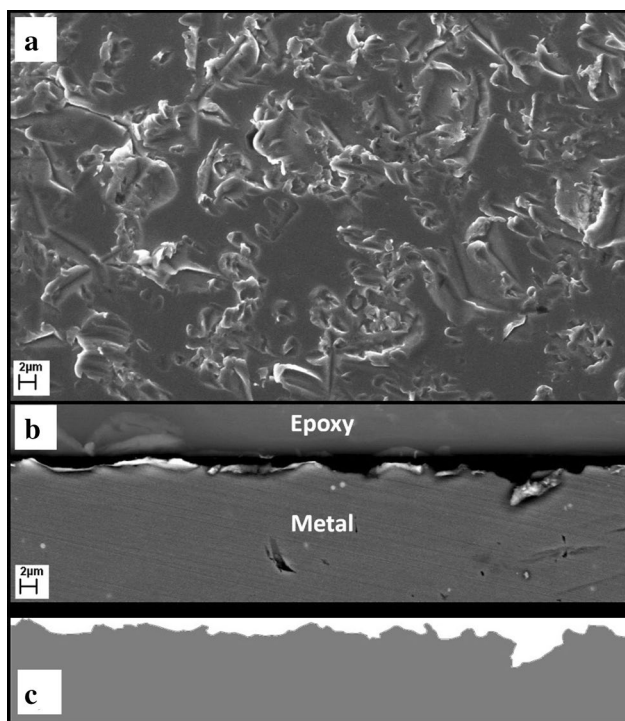
Fig. 5 Scanning electron micrographs for a 17-4PH SS (H900) specimen exposed to an EC experiment: **a** top view (EHT: 20 kV, Observation mode: SE); **b** side view (EHT: 20 kV, Observation mode: BSD); **c** schematic diagram of the solid impacts on the metal surface

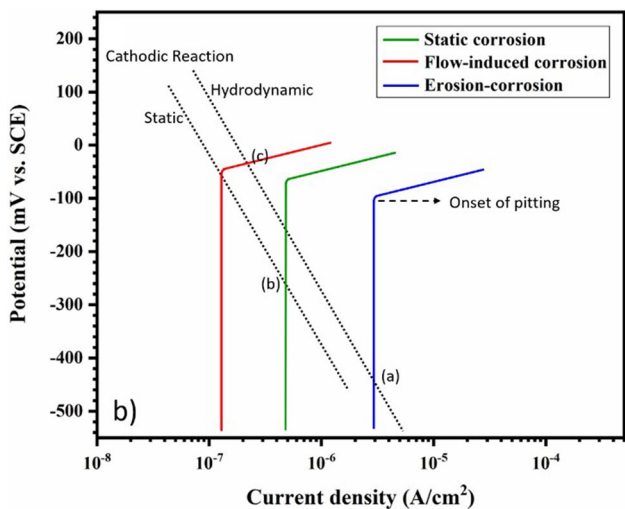
Fig. 6 The variation of E_{corr} and anodic/cathodic branches for SC, FIC and EC conditions

However, the lower E_{corr} for the EC condition has another reason. Generally, by testing in hydrodynamic condition (FIC and EC), the E_{corr} increases as the oxygen feeding on the metal surface is facilitated in comparison with the static condition and accelerates the cathodic reaction, see Fig. 6. Though, considering the depassivation-induced transients observed in the abovementioned figures, it can be said that the surface under the erosive circumstance, would be partitioned into two parts: active or depassivated areas and passive regions. By impact of each particle to the surface,
